ANALYSIS OF BUILDING DAMAGE IN MASHIKI TOWN DUE THE 2016 KUMAMOTO, JAPAN, EARTHQUAKE

Fumio YAMAZAKI¹, Takuya SUTO², Munenari INOUGUCHI³, Kei HORIE⁴, Wen LIU⁵

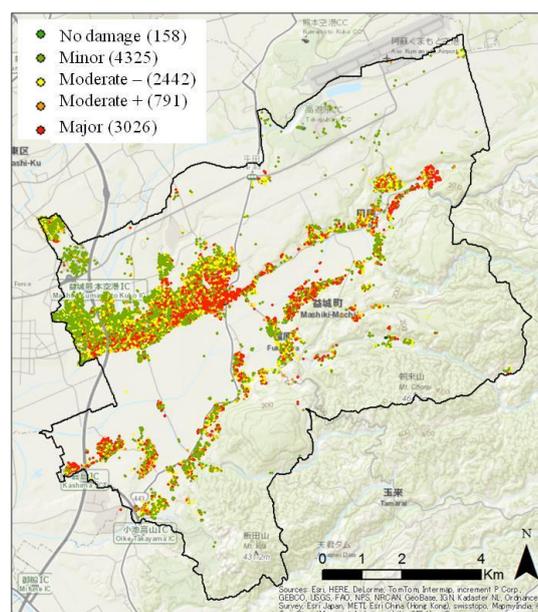
Figure 3. Result of damage (loss) assessment by Mashiki Town government (2017)

The final result of the property loss evaluation is shown in Figure 3 (Mashiki Town 2017). It is observed from the figure that the major damage buildings are distributed widely, especially along the Futagawa fault line. The overall damage grade gets smaller in the northern and eastern areas. In the central part of Mashiki Town, major damaged buildings exist more around the Town office building than around the KiK-net station, which is consistent with field observations.

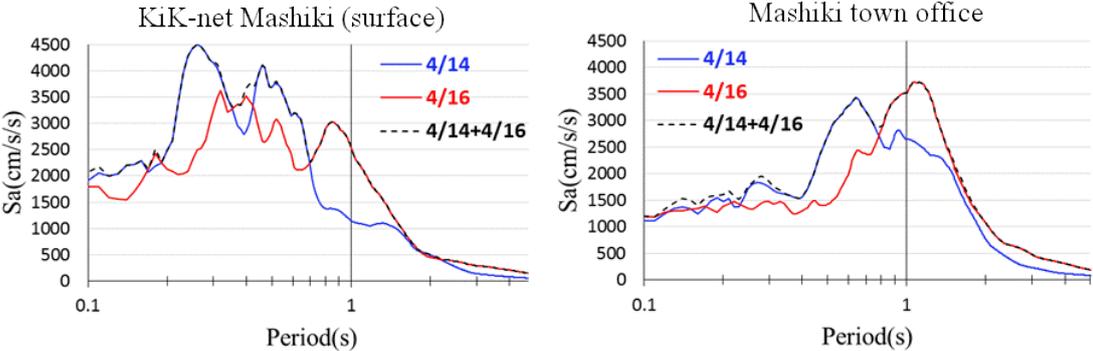
Figure 4. Acceleration response spectra (the resultant of the two horizontal component, 5% damping ratio) for the records at KiK-net Mashiki station and Mashiki Town office.

Figure 4 compares the acceleration response spectra (the resultant of the two horizontal component, 5% damping ratio) for the recorded motions at the two seismic stations for the foreshock (April 14) and the main-shock (April 16). In the figure, the result for the connected time histories (April 14 and April 16 in 5-s interval) is also plotted. It is seen for the KiK-net station that in a short period range less than 0.7 s (0.8 s for the Town office station), the April-14 event exhibits higher response values than those of the April 16 event. But in the longer period range, the April 16 event shows higher response values. It is also noticeable, especially for the April 16 event, that the Mashiki town office record shows much higher values than those of the KiK-net stations in the period longer than 0.7 s, which corresponds to the structural damage of wooden buildings in Japan.

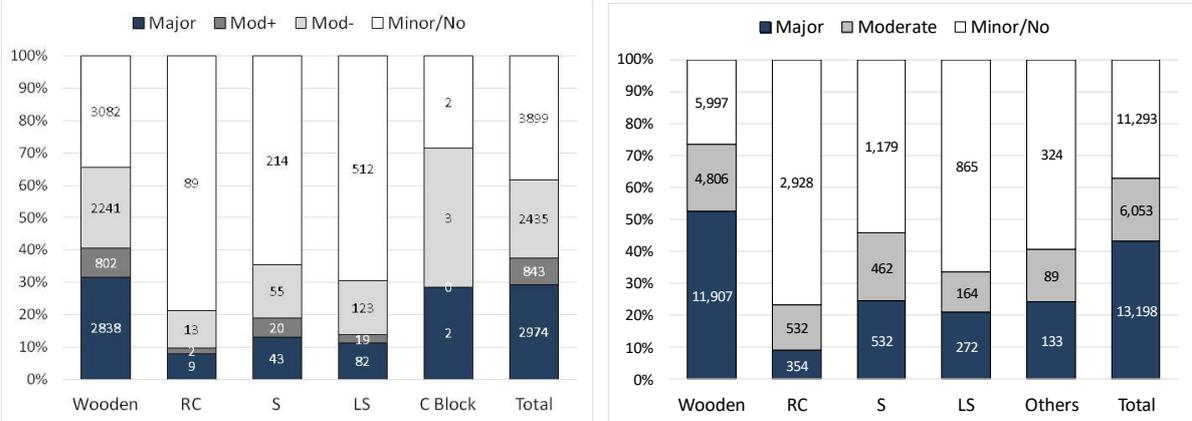
Figure 5. Damage classification of buildings by local governments with respect to the structural type.

The building damage data shown in Figure 3 were analyzed based on the structural material and construction period. From all the loss assessment data, non-residential or non office-use buildings, such as a storage barn, were excluded. Figure 5 shows the damage classifications for a total of 10,151 buildings in Mashiki Town due the 2016 Kumamoto earthquake and that for 30,544 buildings in Nada Ward due the 1995 Kobe earthquake (Yamazaki & Murao 2000). The ratio of major damage for each structural type (material) is in the order of "wooden", "Steel (S)", "Light Gauge Steel (LS)", and "Reinforced Concrete (RC)" buildings for the both datasets. Although there is a 21-years time difference, the vulnerability of buildings with respect to the structural type is quite similar. Note that at the time of the Kobe earthquake, the damage class "Moderate" corresponded to the monetary loss ratio $20\% \leq r < 50\%$, which is the summation of "Moderate+" and "Moderate-" in the Mashiki data.

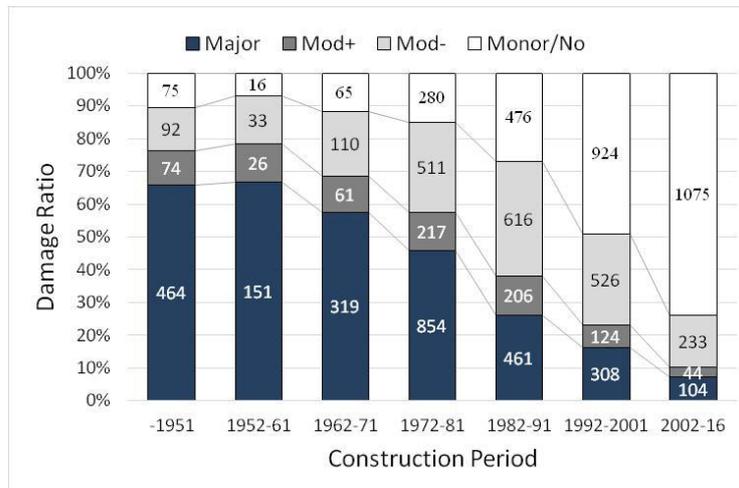
Figure 6. Damage classification of wooden buildings in Mashiki Town with respect to construction period.

The effect of construction period, which corresponds to the change of seismic code in Japan, was then investigated only for wooden buildings since the number of buildings for other structural types is not large enough. Figure 6 shows the damage ratio of wooden buildings in Mashiki Town with respect to the construction period and damage (loss) category. It is clearly observed that within the construction period of 1982-2016 that corresponds to the new seismic code in Japan the damage ratio becomes smaller for newer wooden buildings. Note that the seismic provision for wooden buildings was upgraded in 2000.

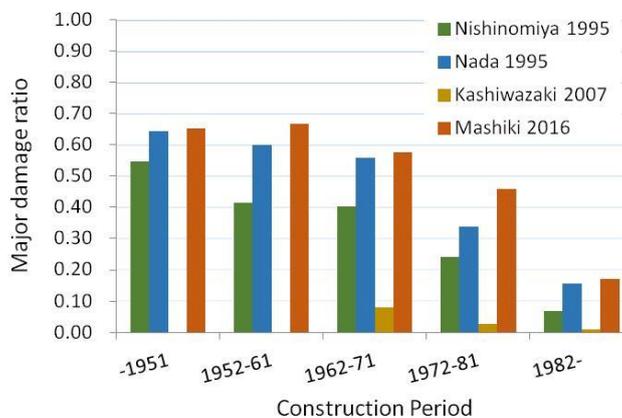
Figure 7. Compares the major damage ratio class for wooden buildings with respect to the construction period for four different datasets in Japan.

In the damage category, "Major", which represents the monetary loss over 50%, is most important since the demolition of the building is a normal situation for this class. Figure 7 compares the ratio of major damage class for wooden buildings with respect to the construction period for Nada Ward in Kobe City (Yamazaki & Muraio 2000) and Nishinomiya City (Yamazuchi & Yamazaki 2000) due to the 1995 Kobe earthquake, and Kashiwazaki City (Nagao et al. 2011) due to the 2007 Niigata-Chuetsu-Oki earthquake, and the Mashiki Town data in this study. For the same construction period, the major damage ratio of the Mashiki Town is almost the same level as that of Nada Ward. The damage ratio of Nishinomiya City is slightly small than that of Nada Ward since the city includes the area of lower seismic motion in the northern part.

The major damage ratio of Kashiwazaki City was much lower than the other three locations although the strong motion records are in the comparable level. Similarly, the major damage ratios for recent earthquakes in Japan were much smaller than that in the Kobe earthquake for the same ground motion level. A few reasons are considered to explain this discrepancy. First, the damage assessment method was not unified and the local governments issued higher damage grades following citizens' requests. The regional difference in construction practice for wooden buildings may be the second reason. In the

western Japan, like Kobe and Kumamoto, wooden houses are more vulnerable than those in the eastern (northern) Japan since typhoons are a more frequent natural hazard than earthquakes, and thus heavy roofs were dominant for older wooden houses in the western Japan. The lack of seismometers at the time of the Kobe earthquake gave uncertainty in estimating strong motion distribution.
