DAMAGE DISTRIBUTION OF THE JUNE 2017 M_w 6.3 LESVOS (NORTH AEGEAN SEA, GREECE) EARTHQUAKE AND EMS-98 APPLICATION TO THE TRADITIONAL SETTLEMENT OF VRISSA

ABSTRACT

Keywords: building damage; earthquake; Lesvos; EMS-98; masonry buildings

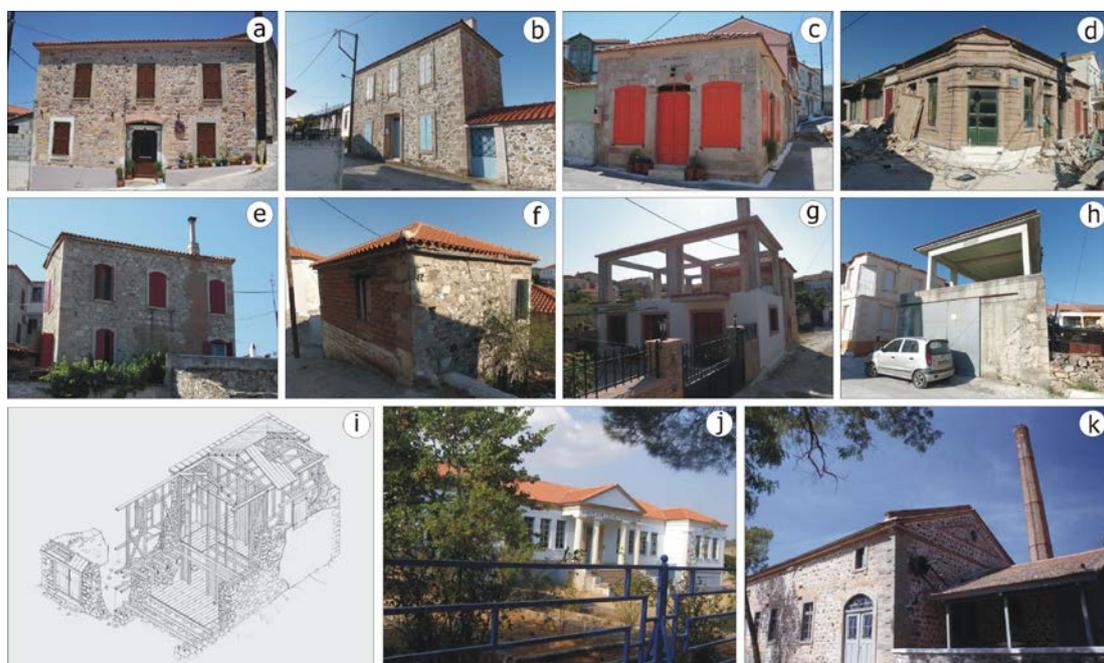
Figure 2: The dominant building types in Vrissa comprise masonry buildings (a-f) and R/C buildings (g-h). The masonry buildings constitutes the majority of the building stock of Vrissa. They mainly include massive stones (a-d) and mixed types including mainly massive stones and perforated bricks (e, f). Their construction is dated back to the late 19th or early 20th century after repeated destructive earthquakes of the 18th century and more specifically from 1845 to 1889. (i) Antiseismic structures with dual structural system were also detected in the affected area. (j-k) Special structures such as school buildings and industrial facilities were also observed.

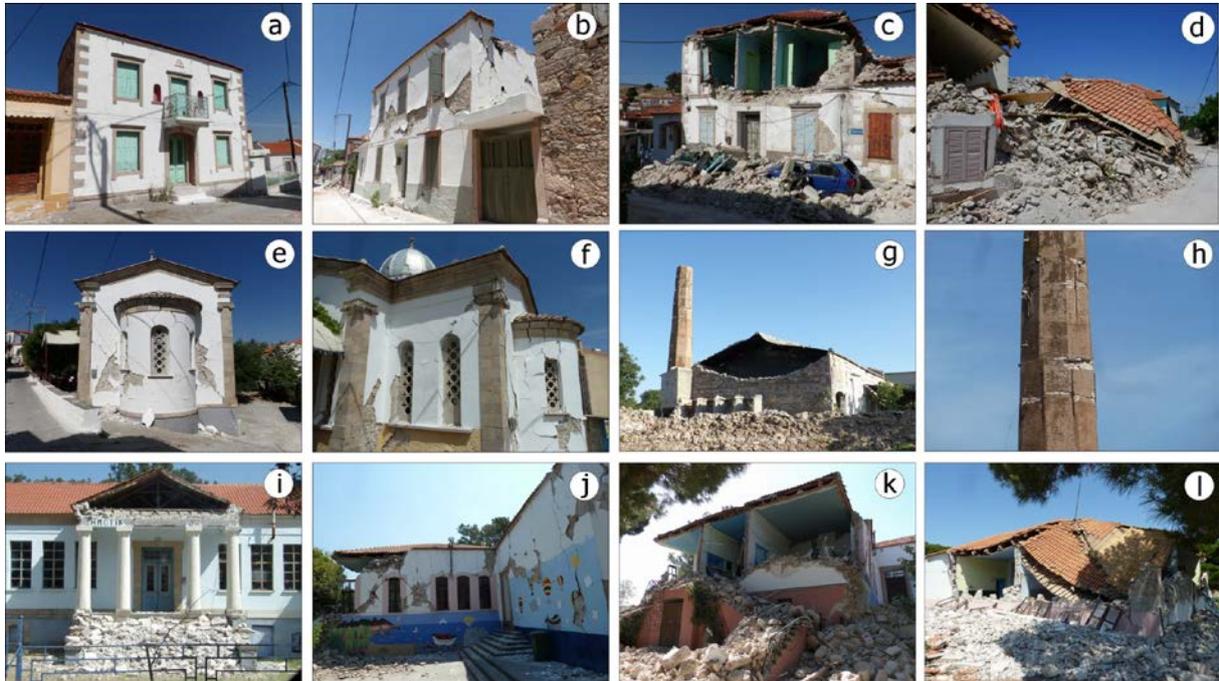
The stone masonry buildings suffered the most by the 2017 Lesvos earthquake. They sustained (a) damage grade 1 (negligible to slight damage) comprising hairline cracks in the load-bearing masonry walls, (b) damage grade 2 (moderate damage) including cracks in many walls, detachment of small pieces of places from the walls and partial collapse of chimneys (Fig. 3a), (c) damage grade 3 (substantial to heavy damage) comprising large and extensive cracking of all masonry load-bearing walls, detachment of large pieces of plaster in all load-bearing walls, dislocation and fall of roof tiles, detachment of the roof from the rest of the structure and fall of gables (Fig. 3b), (d) damage grade 4 (very heavy damage) including heavy structural failure of roofs and floors (Fig. 3c) and (e) damage grade 5 of partial and total collapse (Fig. 3d). From the earthquake engineering point of view, the damage observed in this dominant type of structures is attributed mainly to their old construction age and their high vulnerability taking into account the fact that their construction is dated back to the late 19th or the early 20th century.

The special structures including temples, post-byzantine structures, museums, schools and industrial buildings with masonry load-bearing walls suffered similar damage with the masonry residential buildings. More specifically, temples suffered damage comprising cracks in most of the masonry walls (Fig. 3e-f) and in other parts such the dome, the columns, the aisles, the apse and the gable. Post-byzantine structures suffered the aforementioned damage as well as partial collapse of the walls.

Industrial buildings suffered partial collapse of the perimeter masonry walls and damage of the masonry chimneys on the verge of collapse (Fig. 3g-h). A typical example is the industrial building located at the northern entrance of Vrissa settlement comprising an oil mill along with its masonry chimney (Fig. 3g-h). The main building is composed of masonry load-bearing walls built with roughly treated stones and handmade solid clay bricks, while the masonry chimney has been built with solid clay bricks (Fig. 3g-h). Unfortunately, both structures were abandoned since the late 90s, but they were typical examples and reminders of the industrial prosperity of Vrissa during the late 19th century. Schools suffered fall of the gable above the entrance and partial collapse of the load-bearing masonry walls (Fig. 3i-l).

As regards traditional buildings with the dual structural system, they performed better than the masonry structures with load-bearing walls. The primary structural system comprising the masonry walls of the ground floor sustained no structural damage and light non-structural damage including cracks of the masonry. The secondary structural system showed good performance during the earthquake sustaining successfully the vertical loads of the upper floor and resulting in still standing residential buildings after the earthquake, despite the fact that the masonry suffered damage varying from large cracks to partial collapse.

Figure 3. Representative photos of the observed damage in Vrissa settlement. (a) damage grade 2, (b) damage grade 3, (c) damage grade 4 and (d) damage grade 5 in masonry buildings with load-bearing walls. The masonry monumental buildings (e-f) and the masonry industrial buildings and related facilities (g-h) suffered damage similar to masonry residential buildings. (i-l) Masonry schools suffered similar damage. The Vrissa elementary school suffered near total collapse.

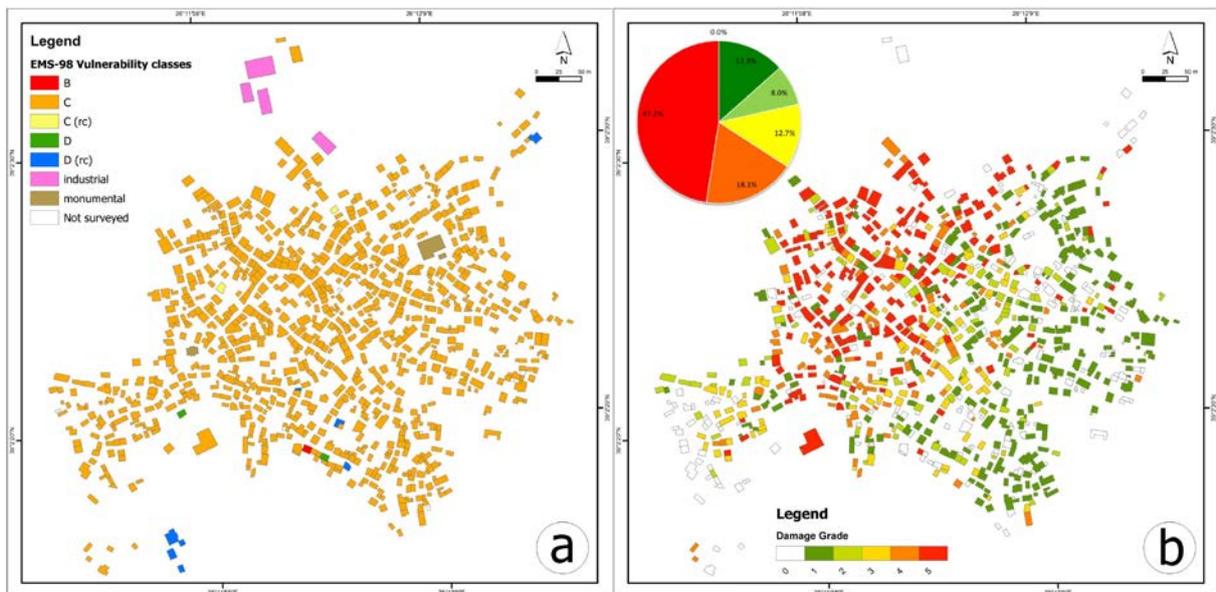
Based on the fact that (a) since 1889 no strong earthquake struck Lesvos until 2017 and (b) Vrissa is a traditional settlement of Lesvos, described as a preserved settlement according to the Governmental Gazette of Hellenic Republic, the majority of buildings include masonry structures belonging to the vulnerability class C (Fig. 4a), while the minority comprises very few R/C buildings belonging to the vulnerability class D (Fig. 4a).

Based on the damage distribution in Vrissa, it is concluded that its northwestern part is the worst affected characterized by damage grades 4 and 5 including partial structural failure of roofs, floors and walls as well as total or near total collapse respectively (Fig. 4b). 47.2% of the surveyed buildings of vulnerability class C suffered damage grade 5, 18.1% damage grade 4, 12.7% damage grade 3, 8.0% damage grade 2 and 13.3% damage grade 1 (Fig. 4b).

Figure 4. (a) Map of the buildings' vulnerability in Vrissa settlement based on the field macroseismic observations and the EMS-98. A percentage of 99.38% of the buildings are of vulnerability class C. (b) Masonry buildings suffered the most by the 2017 Lesvos earthquake. The observed damage grades varied from 1 to 5 (b). The damage classification into damage grades is based on the EMS-98 (b).

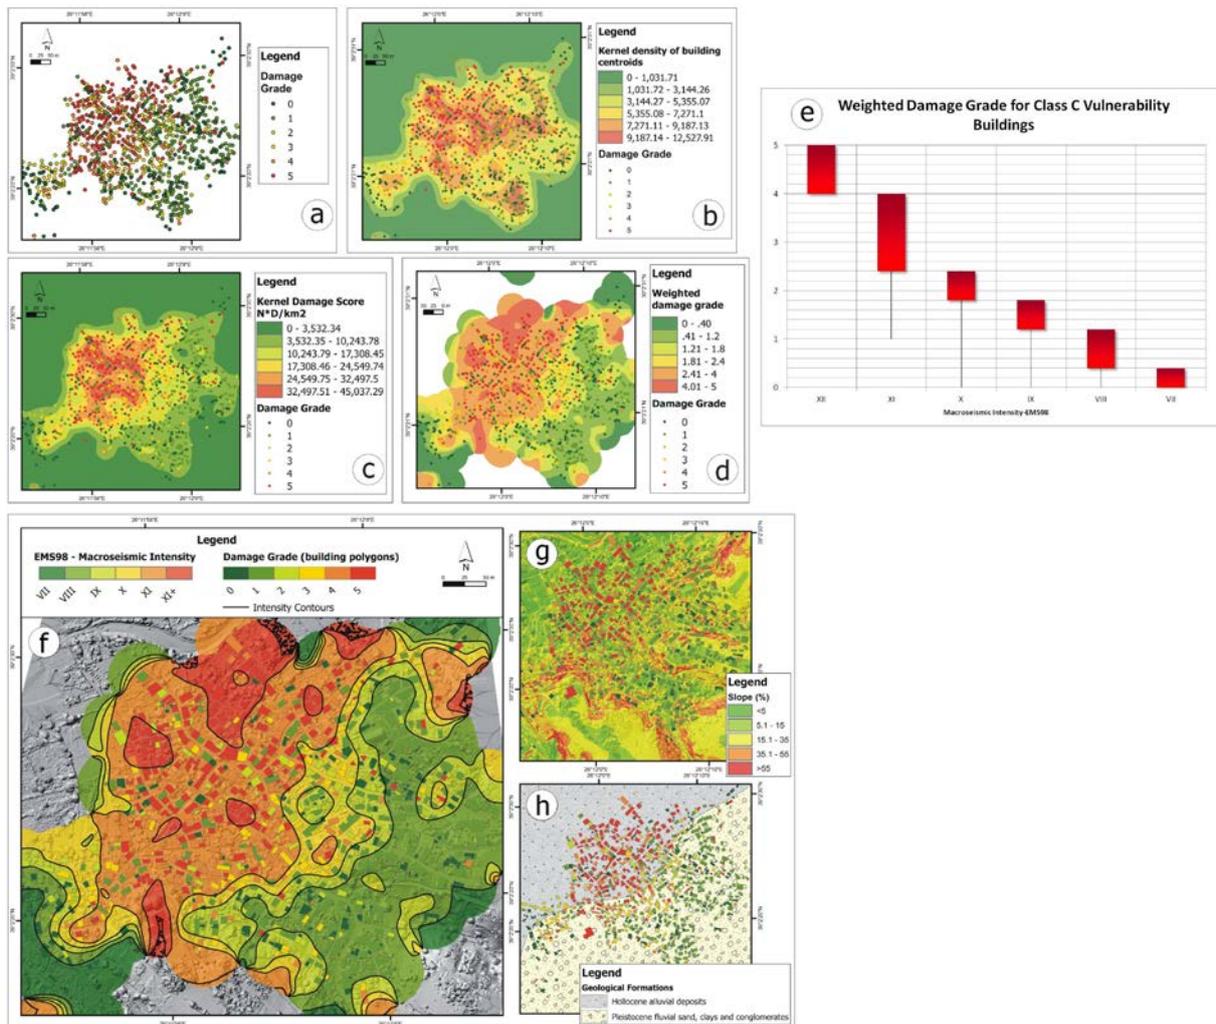
We conclude that this Weighted Damage Grade Map is equivalent to an EMS-98 Macroseismic Intensity Map (Fig. 6f). It has to be noted that, on the basis of C Class vulnerability buildings, damage statistics would justify an intensity of XII, once there are areas that all such constructions have collapsed. However, it was decided to mark these areas with an XI+, because there were not enough R/C buildings in the area, and assigning a XII intensity would be reasonably questionable.

The very heavy structural damage was observed in the western part of Vrissa, while its eastern part remained relatively intact (Fig. 6f-g). Taking into account the geological and tectonic structure, the geomorphological setting and our field macroseismic observations on the type, vulnerability and damage grades of buildings, it is concluded that the worst affected part of Vrissa is founded on Holocene alluvial deposits comprising gray and red clays, sands and gravels, while the slightly affected part is founded on Pleistocene deposits including fluvial sands, clays and conglomerates with thickness of about 100 m (Fig. 6h).

Apart from the worst affected western part of Vrissa founded on alluvial deposits, very heavy structural damage including partial or total collapses was also observed in isolated areas in its southwestern intact part. The occurrence of these damage islet is attributed to the generation of earthquake-induced landslides along geotechnically unstable zones characterized by relatively steeper slopes (Fig. 6g).

Figure 6. (a) Building polygons converted to points (feature to point) for further point density calculations. (b) Kernel density of building centroids. (c) Kernel Damage Score map (Damage Grade*Point Density/km²). (d) Weighted Damage Grade (Kernel Damage Score Map/Kernel Point Density Map). (e) Weighted Damage Grade and respective EMS-98 Intensity degrees. (f) Isoseismal map for Vrissa settlement after the 2017 Lesvos earthquake based on the application of the EMS-98. (g) Geological map of the broader area of Vrissa. (h) Slope map of Vrissa (values %).
