EXPERIMENTAL/COMPUTATIONAL EXPLORATION OF RETROFIT STRATEGIES FOR THE PIEDRAS BLANCAS LIGHT STATION

ABSTRACT

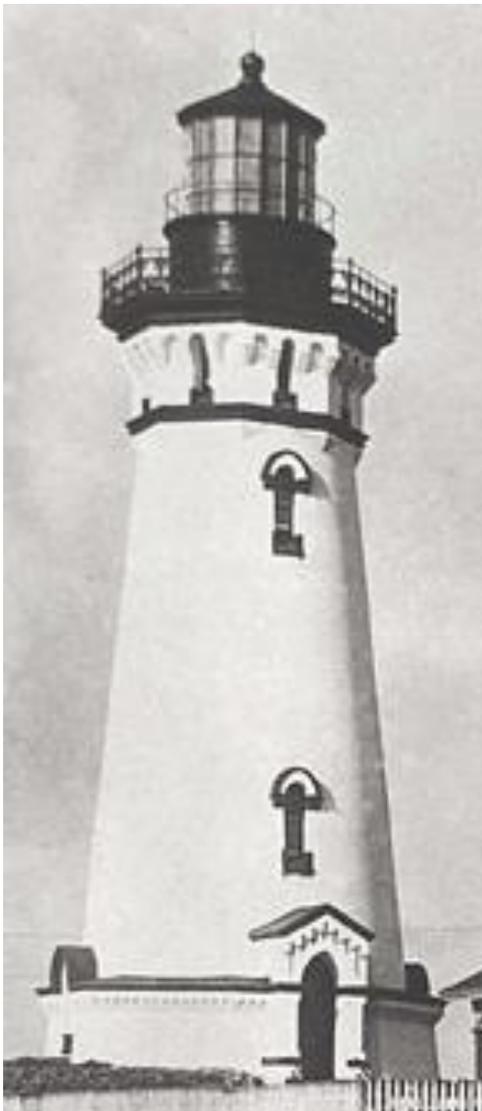
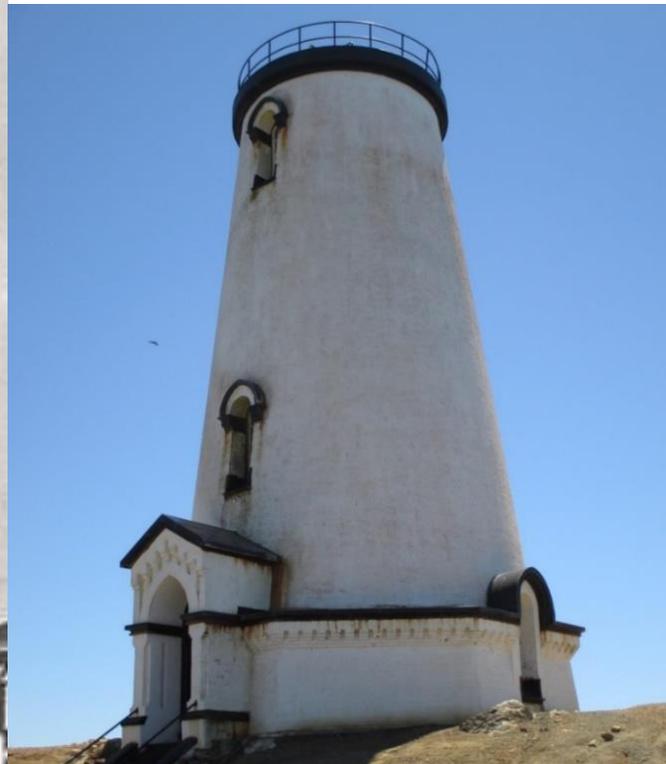
Figure 2. Piedras Blancas Light Station tower

(a) Original configuration (PBLSA, 2017)

(b) Current configuration

The Piedras Blancas Light Station tower, a circular twin tapered unreinforced clay brick masonry wall structure, is located at 15950 Cabrillo Highway on the scenic central coast of California in close proximity to the National Historic Landmark, Hearst Castle, and approximately 5.5 miles northwest of the city of San Simeon, see Figure 1. The light station tower began operation in 1875. Originally standing 30.48 meters (100 feet) tall including the 3.05 meters (10 feet) tall pedestal at the base, the tower sustained extensive damage in an earthquake on December 31, 1948. The epicenter of the magnitude 4.6 earthquake was approximately 9.67 kilometers (6 miles) offshore. Even through the earthquake accelerations were not equivalent to the design level values of current codes, the damage to the tower was significant enough for the Coast Guard to demolish the top 9.14 meters (30 feet) of the tower including the watch room and the lantern room as well as the lens, lowering the tower height to its current measure of 21.34 meters (70 feet), see Figure 2. Today the light station tower remains operational as an active aid-to-navigation.

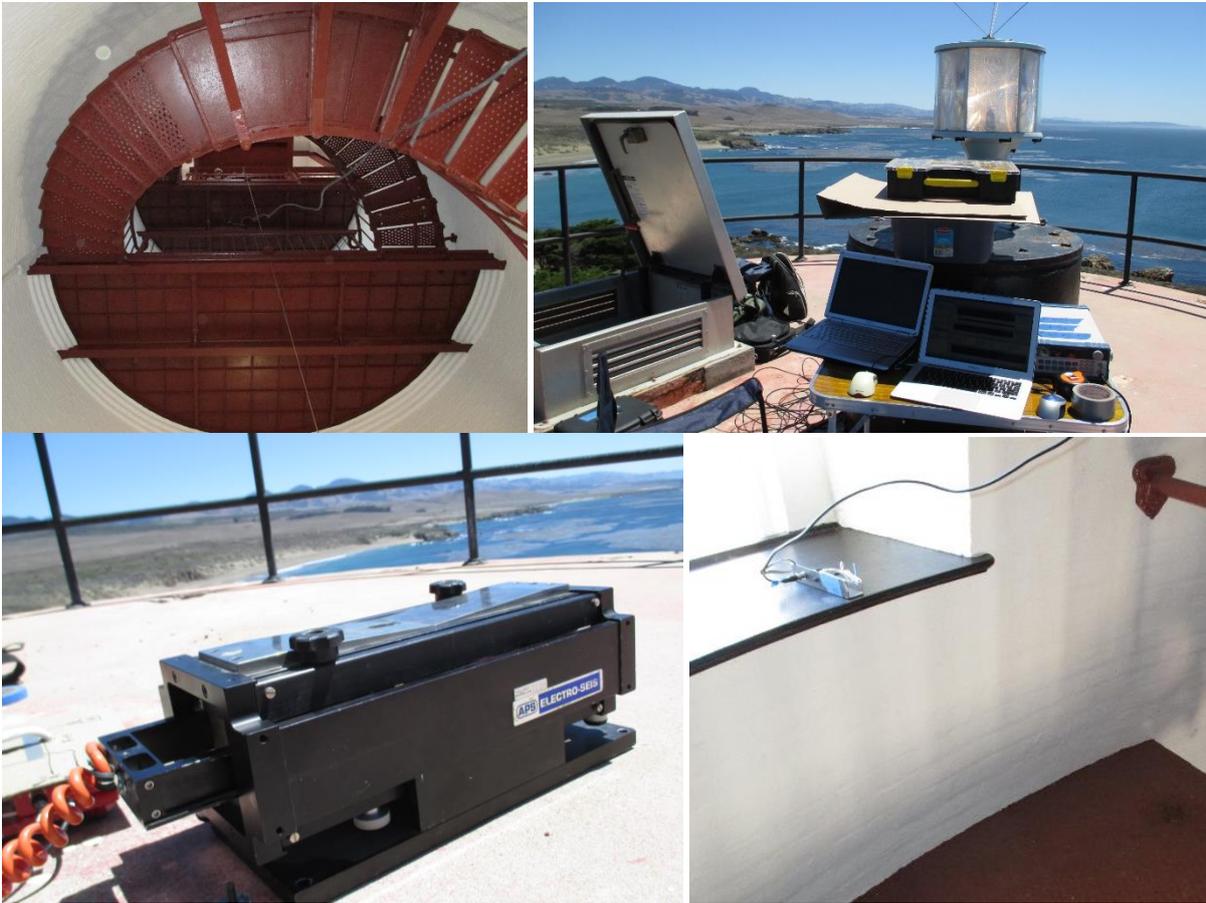
Figure 4. UL-FVT frequency and mode shape experimentation

Ambient vibrations were measured first to provide a rough estimate of the tower fundamental frequencies. The maximum ambient vibration readings ranged between 20-30 micro-g's at the tower top. Next a linear shaker was placed in the optimal location on the light station tower top to excite the structure to approximately 3000 micro-g's, or roughly 100 times the ambient vibration levels, allowing for clear identification of the tower resonant response (see Figure 4). With very low damping, dynamic amplification in the range of 50-100 times is predicted by standard structural dynamics equations (Chopra, 2012). Next, Ultra-Low Forced Vibration Testing (UL-FVT) was used to experimentally determine the fundamental frequencies and mode shapes. These experimental fundamental frequencies and mode shapes (see Figure 5) were compared to the computational results which correlated favorably. This external review of the tower finite element model provided public confidence in the engineering assessments and the future rehabilitation decision making process. UL-FVT will also be conducted after the tower is retrofit as a comparison for the retrofitted tower finite element model.

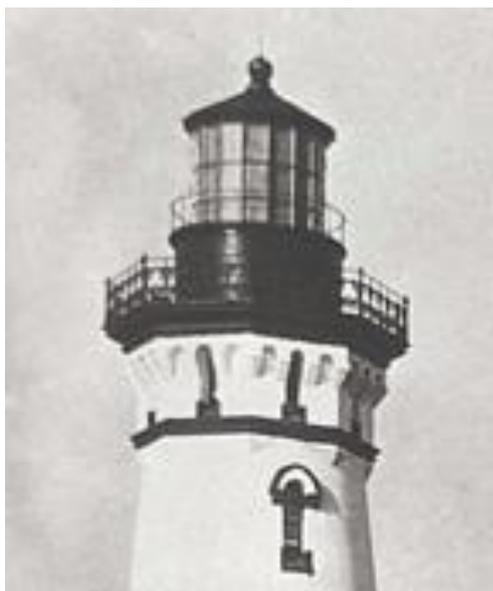
Figure 6. Original light station tower top 9.14 m (30 feet)

A variety of rehabilitation schemes are currently being evaluated by Shoreline Engineering to restore the Piedras Blancas Light Station tower to its original height of 30.48 meters (100 feet), from full restoration of the tower top with clay brick masonry to light weight replica options that maintain the historic character of the structure without adding the full weight of clay brick masonry. The full restoration of the tower top with clay brick masonry while clearly providing the most historically accurate solution would also lead to the highest seismic demand/capacity ratios on the existing tower structure. Any unnecessary additional weight will only exacerbate the current masonry deficiencies, therefore keeping the additional weight to a minimum is a high priority. Fortunately, the tower tapers in thickness from approximately 1m thick walls at the base to approximately 0.7 m thick walls at the tower top, continuing the tower taper with the restoration to 30.48 m with a light weight façade to include the original cast iron ornamentation as seen in Figure 6 will keep the additional weight to a minimum.
