EXPERIMENTAL STUDY OF THREE RETROFITTING TECHNIQUES FOR TYPICAL SCHOOL BUILDINGS IN PERU

Miguel DIAZ¹, Carlos ZAVALA², Luis LAVADO³, Jorge GALLARDO⁴, Roy REYNA⁵

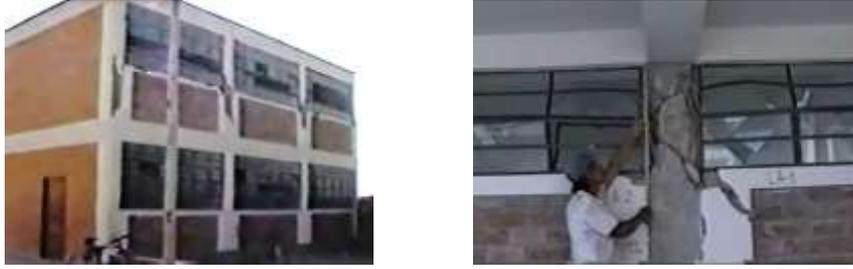
Figure 1. Fermin del Castillo School after Nazca earthquake in 1996, Mw7.7. Zavala, 1996

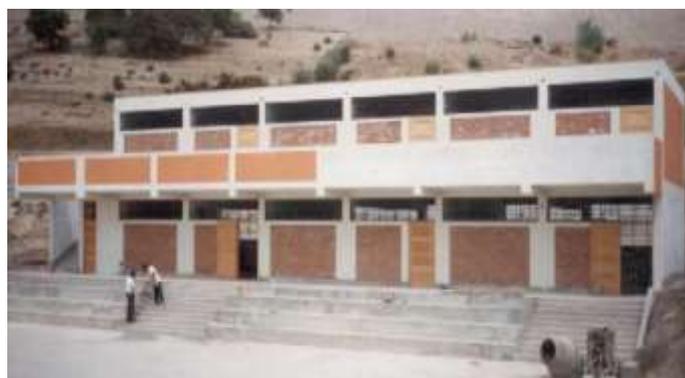
The target school building is the first version of 780-module; which was design with Peruvian earthquake resistant standard of 1977. This module consists of two stories and three rooms per story, as shown in Figure 2. This structure is composed by RC frames in longitudinal direction and confined masonry walls in the transversal direction, as illustrated in Figure 3. Dimensions of room is 7.80 m by side; that's why, it was named 780-module. It is important to mention that longitudinal direction suffered severe damages, while transversal direction was slightly damaged due to large earthquakes.

Figure 2. School building based on 780-module

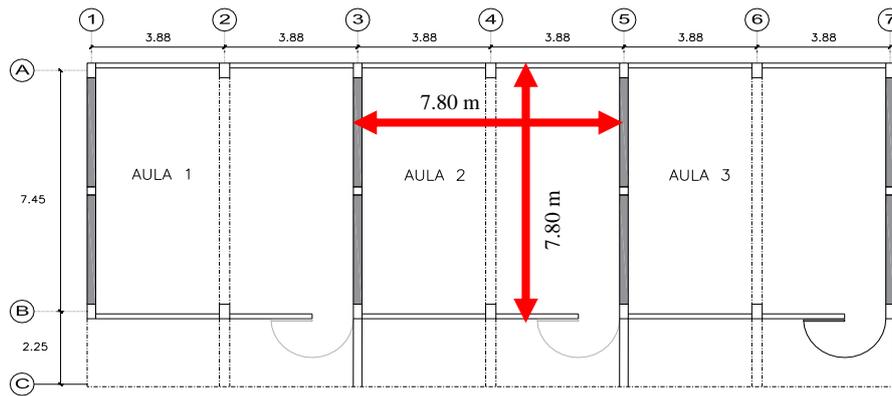
Figure 3. Typical floor of 780-module

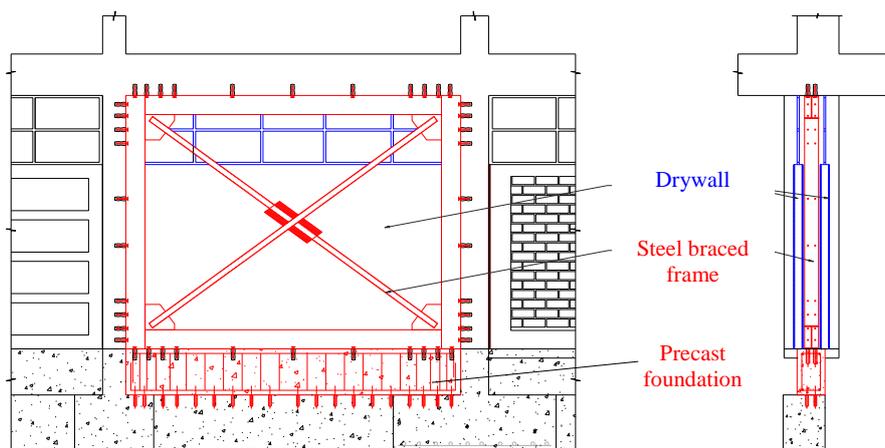
This technique involves inserting a steel concentrically braced frames to the existing RC frames in the longitudinal direction of the school building, as shown in Figure 4. Steel frames and steel braces are composed by W8X18 and HSS2.5x2.5x3/16 sections, respectively; which are connected by bolts of 5/8" of diameter. The steel members are ASTM A-36 and bolts are ASTM A-325. In the case of first story, a precast foundation has to be placed, because the existing foundation has poor bearing capacity.

Figure 4. Scheme of ACMAC technique

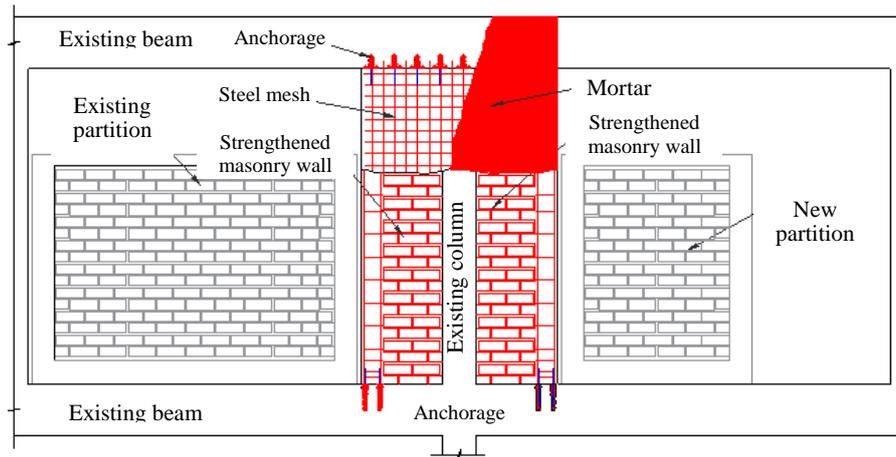
This technique involves inserting a masonry wall on the sides of the existing column, as illustrated in – Figure 5. Additionally, the masonry wall and the existing column is covered with wire-mesh and cement-sand mortar. The wire mesh of 100x100mm size and 4.2 mm diameter (commercially named Q-139) is fixed to the masonry wall through diameter 1.65 mm wire at 200 mm spacing, in horizontal and vertical directions using drill (Zavala et al., 2009 and Diaz et al., 2016). Vertical rebar dowels of 6 mm diameter are used to connect the wire-mesh to the existing structure. Dowels are extended a minimum of 150 mm into the wire-mesh and be hooked to footing, slabs or beams at each 200 mm for fixing the wire mesh. The compressive strength of mortar was 14 MPa, and the yield strength of steel bars was 420 MPa.

Figure 5. Scheme of MARM technique

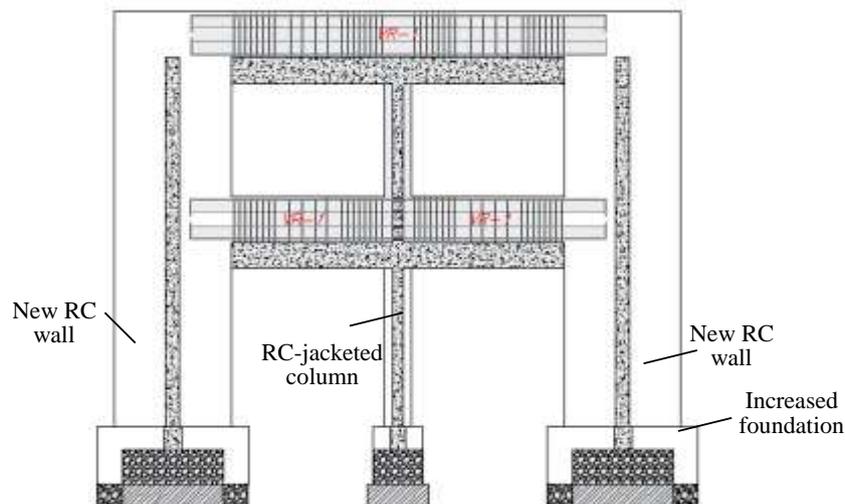
This technique involves inserting a reinforced concrete wall on the sides of the existing column and a jacketing of existing columns; additionally, beams are coupled to inserted RC walls and RC jacketed columns, as in shown in Figure 6. The existing foundation is increased in order to insert the new RC elements.

Figure 6. Scheme of IMACA technique

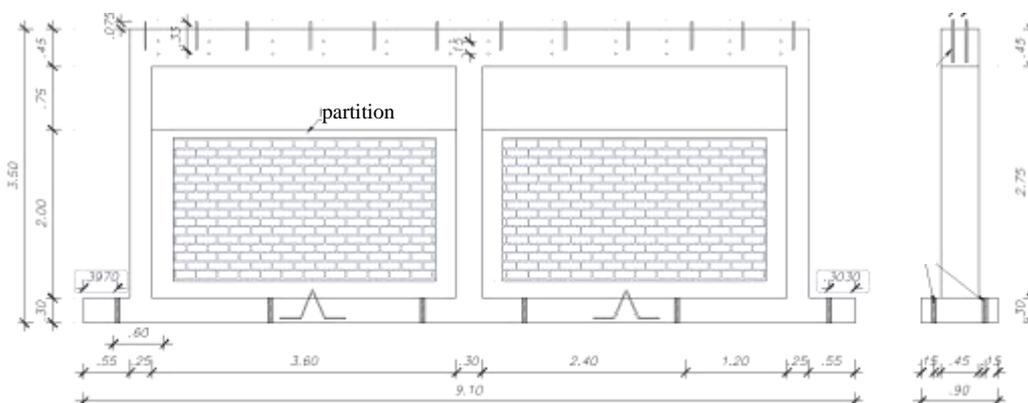
This specimen represents the existing frames without retrofitting, based on the representative frame of 780-module, as shown in Figure 7. The partition is a confined masonry wall, where tie columns presented null joint separations from RC columns.

Figure 7. Non-retrofitted specimen

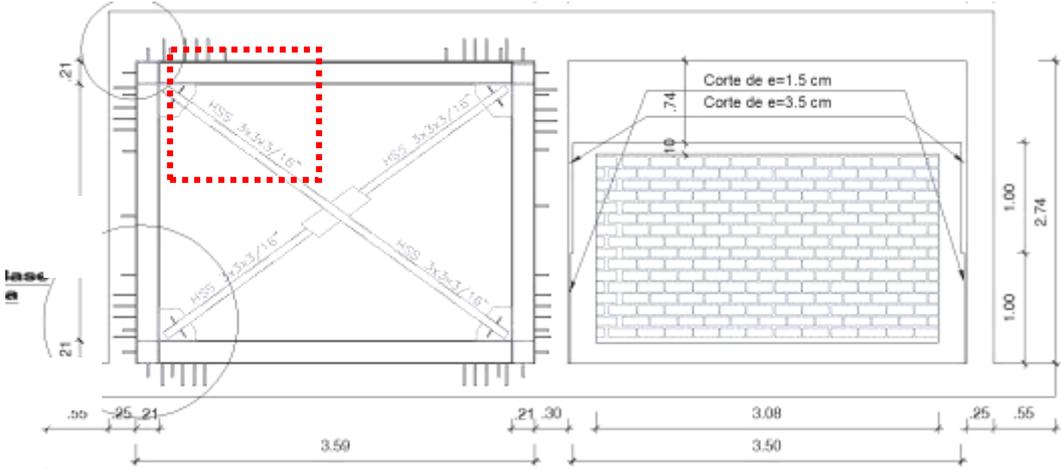
This specimen represents the existing frames with retrofitting by ACMAC technique, as shown in Figure 8. Specimens with ACMAC technique presented two versions; second specimen (2) had a greater number of bolts at connections. P780-ACMAC-1 had three bolts at the connection between RC beam (or RC column) and steel frame; while P780-ACMAC2 had a total of seven bolts at the same connection, as shown in Figure 9. The joint separation was improved; tie column from the confinement of masonry wall were cut 40 mm from level of 1 m to the top in P780-ACMAC-1; while, tie columns were cut 15 mm from base to level of 1 m, then 30 mm to the top in P780-ACMAC-2.

Figure 8. Retrofitted specimen with ACMAC technique

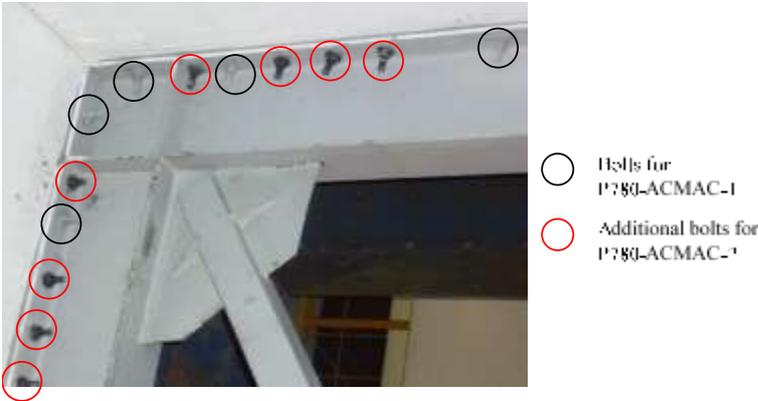
Figure 9. Configuration of bolts at connections between existing RC frames and inserted steel frames

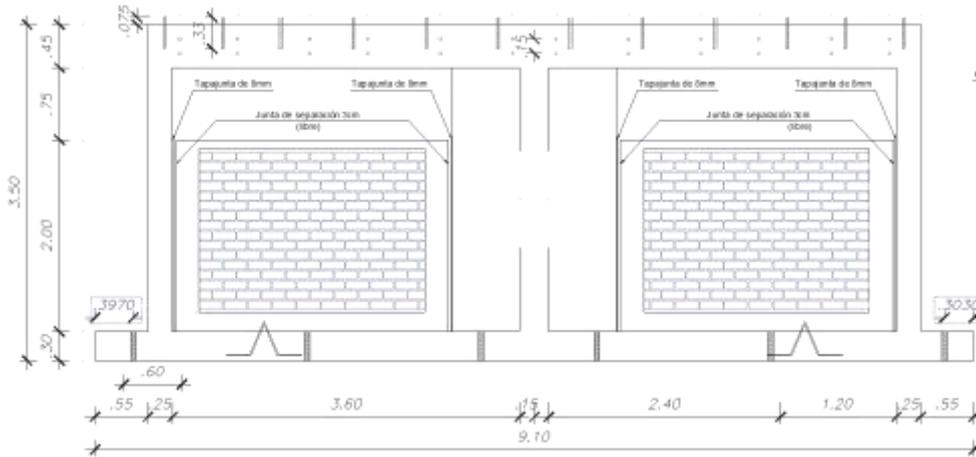
This specimen represents the existing frames with retrofitting by MARM technique, as shown in Figure 10. Masonry partitions are replaced, and the joint separation was 30 mm.

Figure 10. Retrofitted specimen with MARM technique.

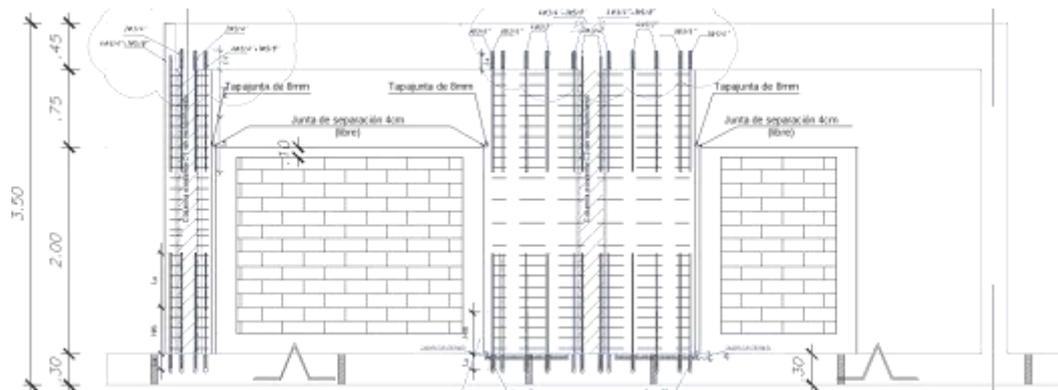
This specimen represents the existing frames with retrofitting by IMACA technique, as shown in Figure 11. Masonry partitions are replaced, and the joint separation was 40 mm.

Figure 11. Retrofitted specimen with IMACA technique.

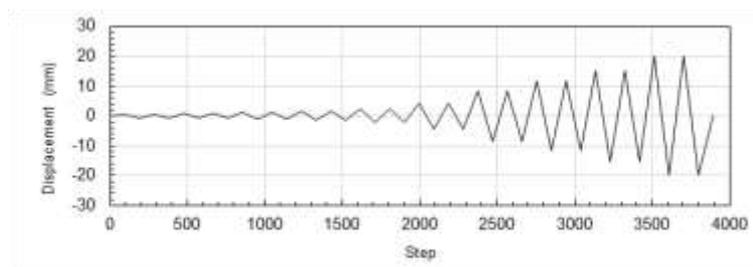
The test setup consisted of four hydraulic static jacks, with the 500 kN loading capacity of each jack and a stroke of +/- 250 mm. Two jacks applied simultaneously lateral cyclic loading to simulate the seismic load, while other two jacks applied a constant vertical loading to simulate the gravity load due to upper floors. The axial load remained constant during test at 550 kN. The displacement protocol used in tests is shown in Figure 12. The target displacement is repeated; thus, two cycles with the same deformation are obtained.

Figure 12. Lateral displacement protocol for lateral cyclic loading tests

According to the lateral displacement protocol shown in Figure 12, the target amplitudes were reached twice, because two consecutive cycles of the same amplitude were applied. The skeleton curves, which represents the capacity curve, were obtained using peaks of the cycles of the repeated target amplitude, as shown in Figure 16. Figures 17, 18 and 19 are obtained from peak-to-peak of cycles were target amplitude is repeated.

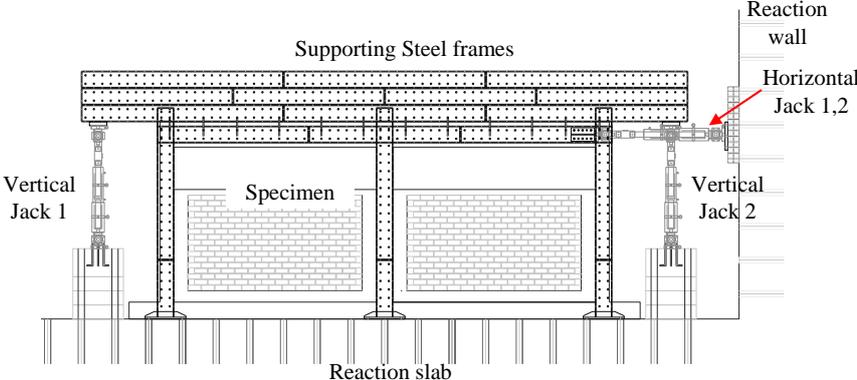
Horizontal jacks were supported by the reaction wall and connected to an assemblage of steel frames for loading transfer, as shown in Figure 13. Vertical jacks were supported by the reaction floor and connected to the steel assemblage.

Figure 13. Loading apparatus for cyclic loading tests

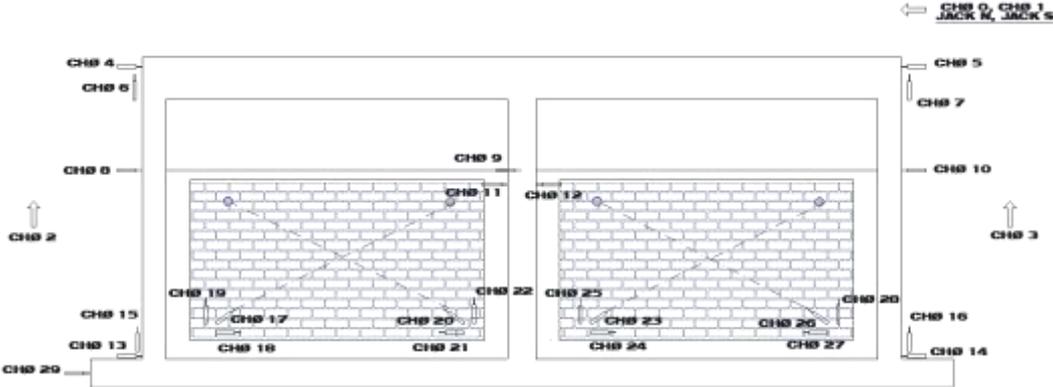
The measuring system consisted of load cells in jacks (CH-00 to CH-03) and LVDTs arranged in the specimen (CH-04 to CH-20), as shown in Figure 14. Configuration of P780 specimen is similar to those of other specimens.

Figure 14. Measuring system for cyclic loading tests of P780 specimen.

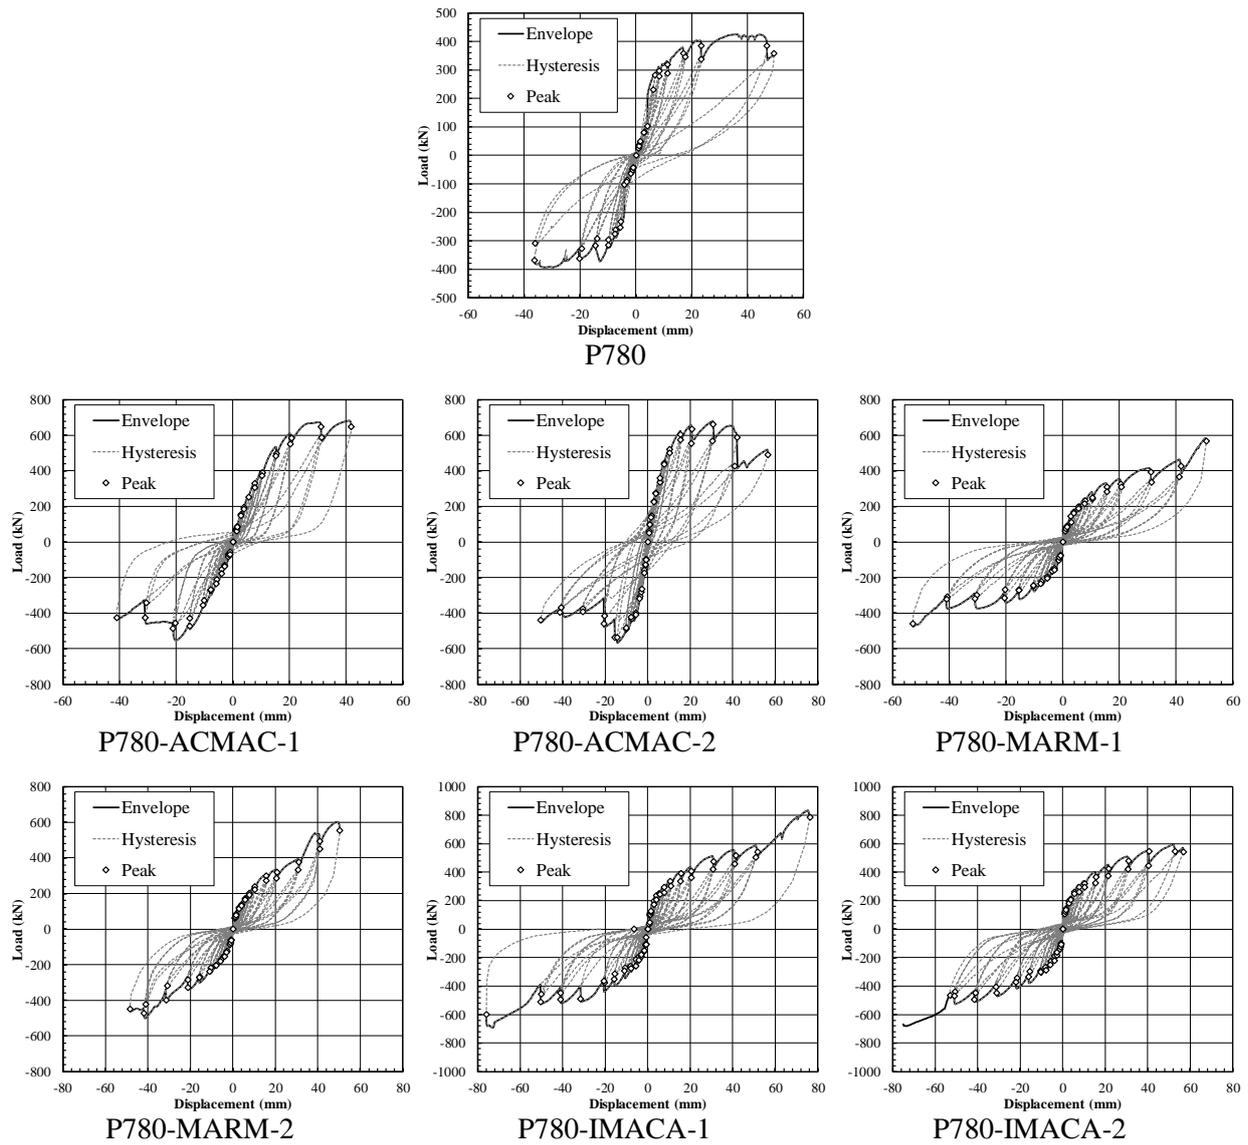
Figure 15 shows hysteretic curves, envelopes and their peaks during each cycle for tested specimens. The maximum restoring force reached during test of P780 specimen was 425 kN, and during test of the retrofitted specimen was 692 kN, approximately.

It is observed in hysteresis curves that beyond 40 mm of lateral deformation at the top, the improvement of the joint separation was not enough for specimens retrofitted with MARM technique. In the case of specimens retrofitted with IMACA technique, the joint separation was not enough beyond 50 mm of lateral deformation at the top. In the case of specimens retrofitted with ACMAC technique, the joint separation was enough. Nevertheless, the maximum restoring force is reached before joint separation was worthless.

Figure 15. Hysteresis curves

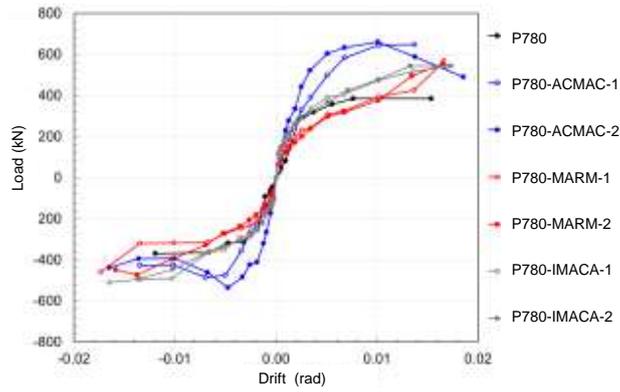
Figure 16. Capacity curves in terms on lateral force and drift

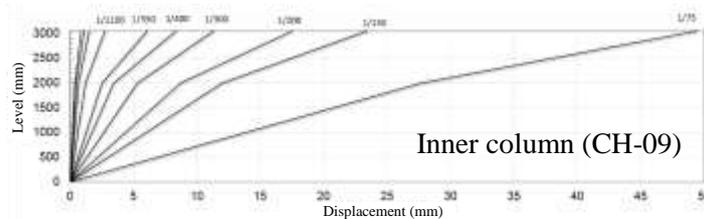
Figure 17 shows the lateral deformation at the level of the inner column. This figure represents the process of short column in P780 specimen during the increment of lateral displacement. Lateral drift are shown at the top of this figure. Beyond 3 mm of lateral displacement at the top of P780 specimen, the shape of columns started changing significantly upper the top of masonry partitions (upper than 2m of level). Thus, partitions started providing stiffness to this specimen. It can be observed that the equivalent stiffness increased beyond 5×10^{-4} rad of drift, approximately, as shown in Figure 18.

Figure 17. Hysteresis curves

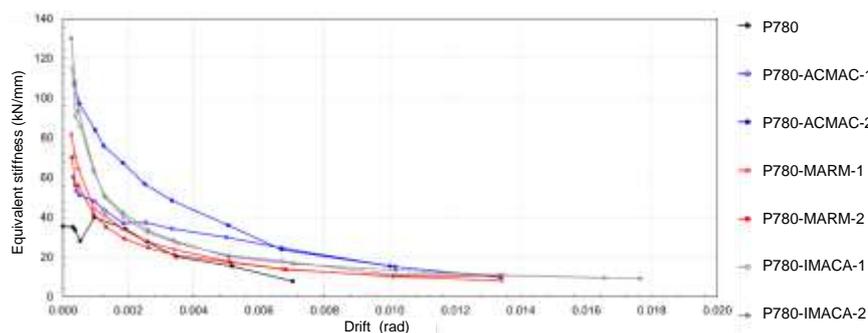
Also, it was observed that the short column effect was avoid in specimens with retrofitting, and participation of masonry partitions was insignificant, corroborating by the progressive degradation of stiffness as shown in Figure 18, because of the improvement of joint separation.

Figure 18. Equivalent stiffness in terms of drift

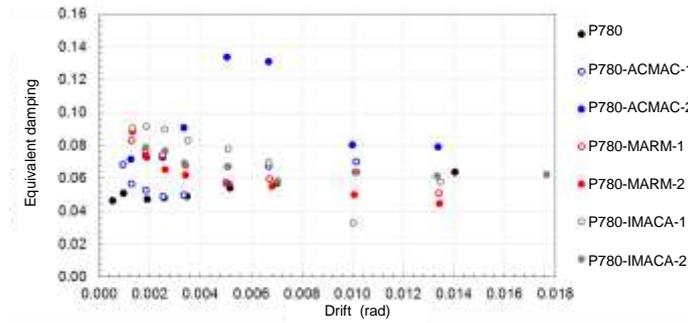
Additionally, index of energy dissipation was calculated from experimental results, in terms of equivalent damping of a cycle, as shown in Figure 19. It is observed that ACMAC technique performed larger energy dissipation (13%, approximately); and this index increased when connection between existing columns and steel frames were improved (P780-ACMAC-2).

Figure 19. Equivalent damping in terms of drift

ACMAC technique performed the largest energy dissipation in this experimental study, which was improved with the increment of bolts at connections between RC columns and inserted steel frames. Specimens retrofitted with ACMAC technique performed better seismic behavior than those retrofitted with MARM and IMACA techniques. Also, the increment of capacity of ACMAC technique given by the improvement of steel frame and RC frame connection was observed.
