## **SEISMIC PERFORMANCE AND RETROFIT OF A HISTORIC MONUMENT ARCH BRIDGE**

### **ABSTRACT**

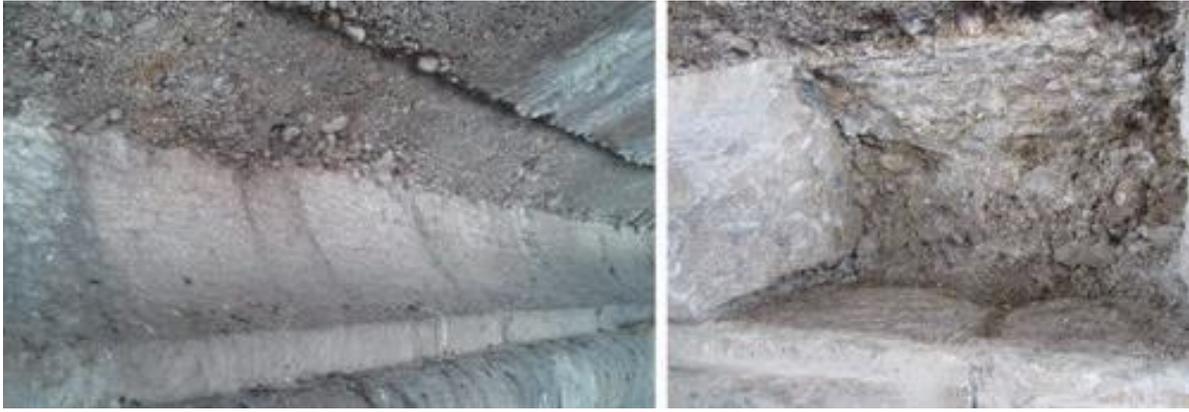
Figure 4. Abutment stone blocks at the left bank of the river and situation after their removal (author's photo)

A traditional way of foundation has been revived once the stone blocks were removed from the bank abutment walls (Figure 4).

The bridge is founded in a traditional way on a structure composed of stone slabs on which the bank abutments of limestone were constructed (local white Hreša stone) as supports for the arch structure. Complementary diagnostic methods were done, based on non-destructive and minor destructive tests methods to allow a wide view of the problem. In this respect, cores were taken out of the structure in order to determine the compressive strength of concrete, determine the presence of deleterious matters in concrete, determine the mix composition of concrete, etc. In order to determine the location and the type of the steel reinforcement minor removal of the concrete cover was done and type of steel was determined, as well as, the degree of corrosion (Ademović et al. 2017).

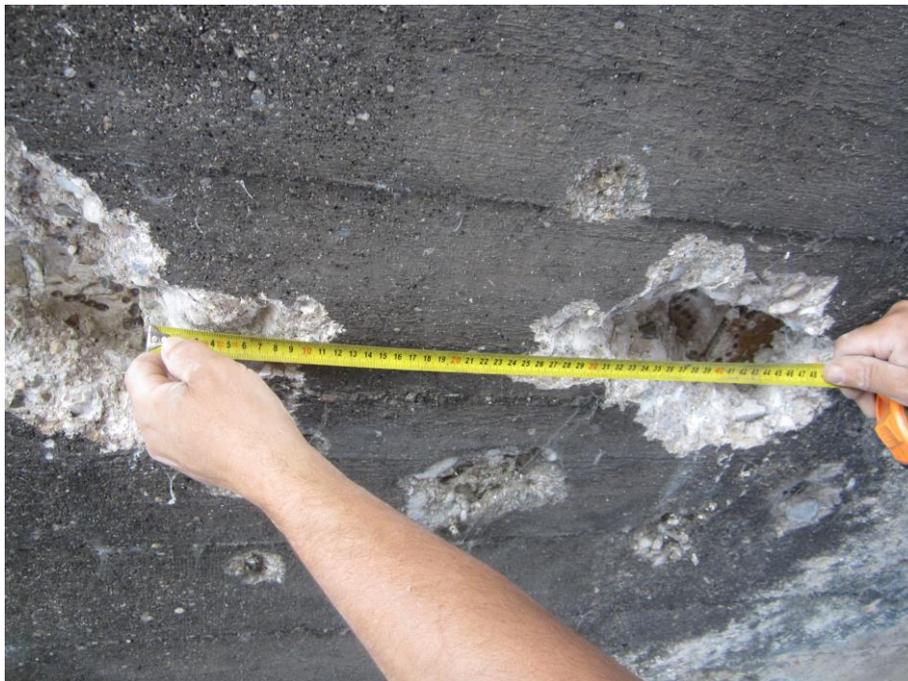
Figure 5. Distance between rigid reinforcement sets (author's photo)

On site tests and laboratory investigations revealed that the arch concrete was of a concrete class MB 20 (equivalent to C15/20 according to Eurocode 2). The structure was reinforced by rigid set of 20 2L 60 x 60 x 4mm at a distance of approximately 45 cm (Figure 5). The steel was classified as steel class Č 0545 according to JUS standards (according to EN 10027-1 E295, and DIN St 50- 2), with the tensile strength of 470 N/mm<sup>2</sup>, and the yielding strength of 285 N/mm<sup>2</sup> (Ademović and Kurtović 2015, Ademović et al. 2017).

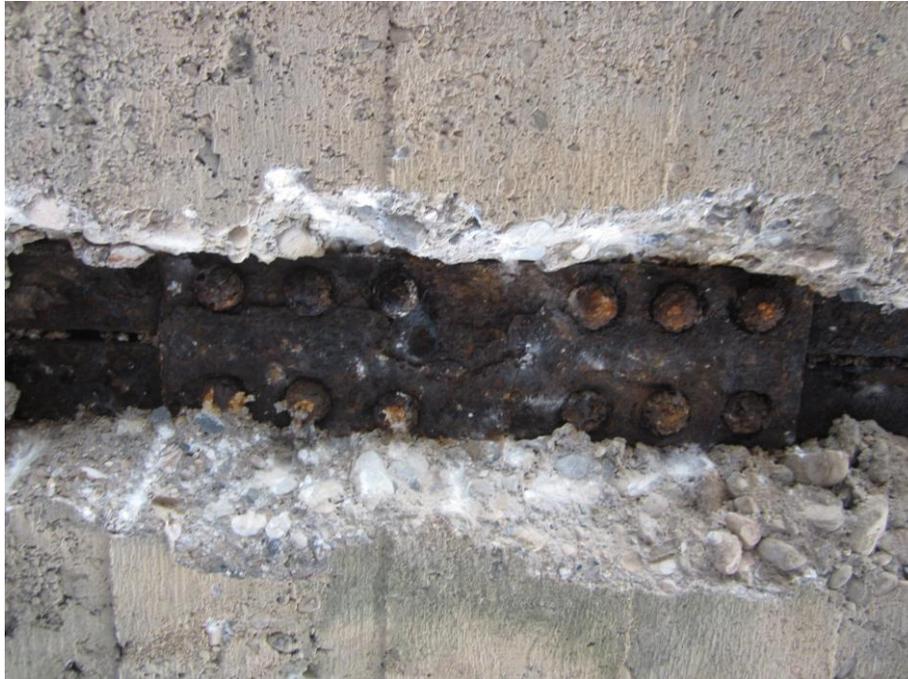
Figure 6. Connection of the rigid reinforcement (author's photo)

The connection of the rigid reinforcement was performed by a steel plate (46 x 13 cm) about 6 mm thick

and a set of six rivets on each side. Placement of the rivets is at an interval of 6 cm. Inner spacing between the rivet sets is 13.5 cm, while the distance from the edge of the steel plate to the first (last) rivet is 4.5 cm. The steel corrosion and scaling were registered on the steel plates used as connections for rigid reinforcement (Figure 6). Further details regarding the visual inspection can be found in (Ademović and Kurtović 2015, Ademović et al. 2017).
