DAMAGE DISTRIBUTION OF THE JUNE 2017 M_w 6.3 LESVOS (NORTH AEGEAN SEA, GREECE) EARTHQUAKE AND EMS-98 APPLICATION TO THE TRADITIONAL SETTLEMENT OF VRISSA

ABSTRACT

Keywords: building damage; earthquake; Lesvos; EMS-98; masonry buildings

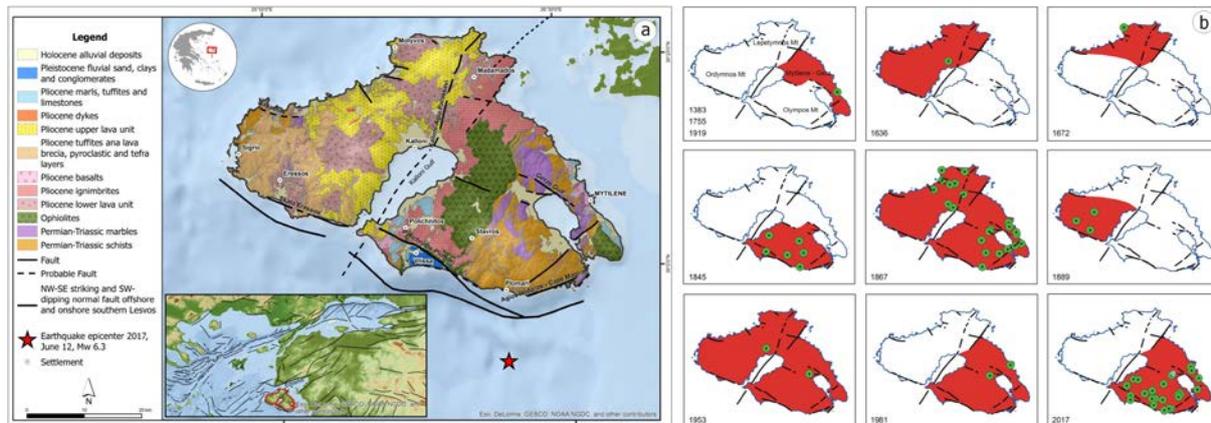
of seismic intensities were also reported after the 1845 (October 11, $M=6.8$, $I_{MAX}=X$), 1867 (March 7, $M=7.0$, $I_{MAX}=X$), 1953 (March 18, $M=7.4$, $I_{MAX}=IX+$) and 1981 (December 19, $M=7.2$, $I_{MAX}=VIII$) (Fig. 1b).

Figure 1. (a) The 2017 Lesvos (Northeastern Aegean Sea, Greece) earthquake was generated offshore southeastern Lesvos by a NW-SE striking and SW-dipping normal fault that constitutes the northern margin of the offshore Lesvos basin located southwards of the island. (b) Areas with high contrasts in seismic intensities during large earthquakes in Lesvos. The maximum intensities have undoubtedly been observed in the southern and eastern part of Lesvos during the 1845, 1867, 1953 and 1981 earthquakes (data from Papazachos & Papazachou, 2003; Taxeidis, 2003; Ambraseys, 2009).

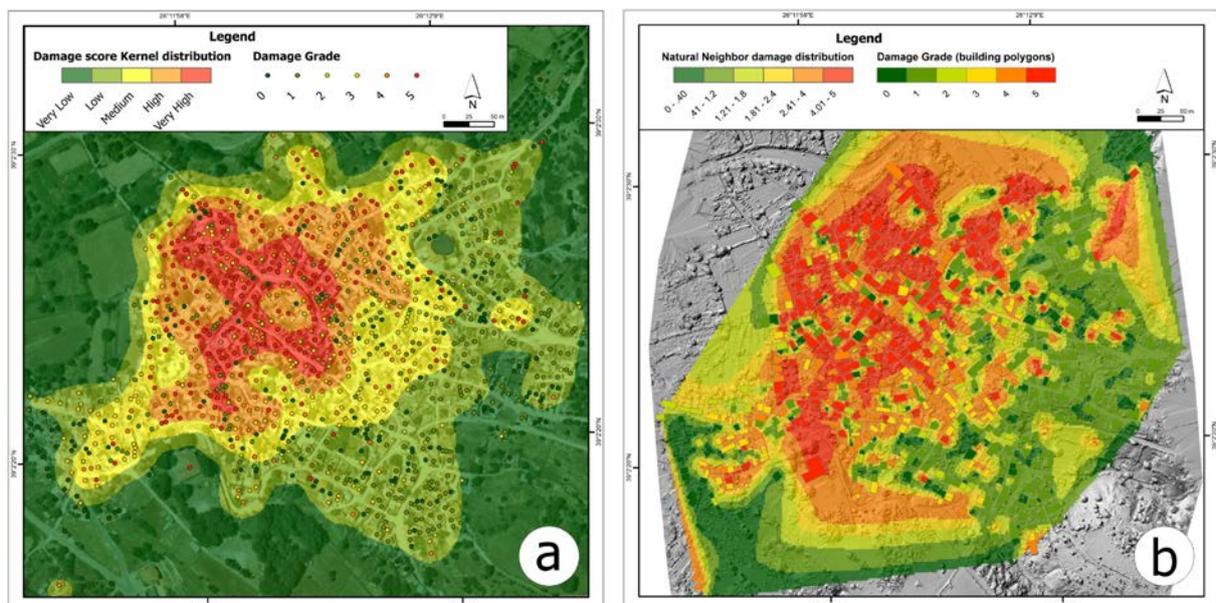
The first attempt was a population density map (Fig. 5a), taking into account the point density of buildings and the damage grade. The map was produced using the centroids of the building polygons to create a Kernel density map, with the number of damage grade used as population value. This map, carries an anisotropy due to not only the damage grade, but also to the shape of the village and the distribution of the surveyed buildings.

Figure 5: (a) Kernel Damage Score distribution based on point density and damage grade for all buildings (search radius 40m, cell size 1m). (b) Simple interpolation (Natural Neighbor method) of damage grades of vulnerability class C buildings for a search radius circle of 40m. The result respects the recorded values, but it would be more comprehensible if it could be somewhat generalized or smoothed.

This map provides a very good picture of the situation, where the most and worst damage occurred. But it also shows a linear distribution and separation of the village into two sectors, the northwest and the southeast, so provocative that requires further analysis. And before controlling factors are analyzed, there should be a refinement of these results.

The simple interpolation of damage grades for buildings of vulnerability class C was also applied, using the Natural Neighbor for a search radius circle of 40m (Fig. 5b). The result depicts the accurate distribution of damage across the village in accordance with the exact position of buildings, but it would be more comprehensible if it could be somewhat generalized or smoothed.
