THE IMPACT OF GRIVA EARTHQUAKES ON STRUCTURES DAMAGE

ABSTRACT

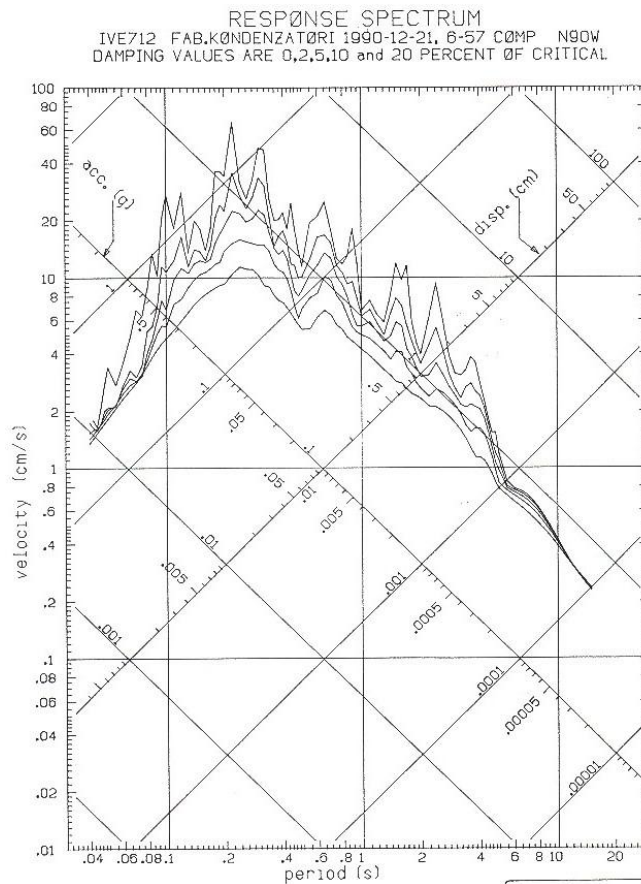
Figure 7. Response spectrum for N90W component.

Figure 7 shows the acceleration, velocity and component displacement response spectra for damping of 0, 2, 5, 10 and 20% of the strongest component recorded at the Capacitors factory in Gevgelija.
