PHOTOGRAMMETRY TECHNIQUES FOR OBJECT-BASED BUILDING CRACK DETECTION AND CHARACTERIZATION

Keywords: close range photogrammetry; object-based; crack detection; building damage mapping; OBIA

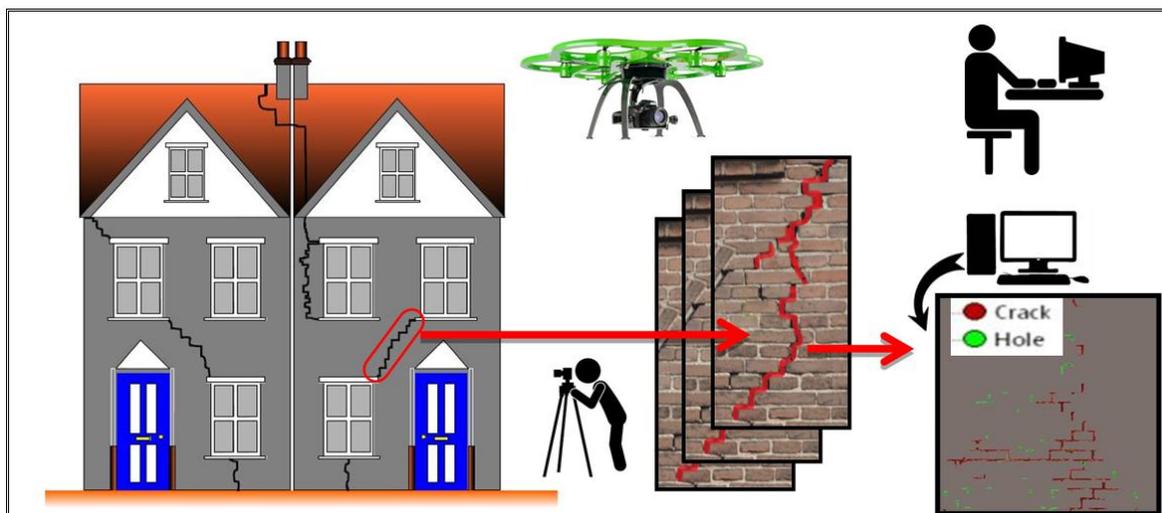
Figure 1. Damage identification and classification procedure

holes. At this stage the information that VHR images could provide (DSM & orthorectified image) will be further used for the OBIA. A hybrid approach for the segmentation process will follow. That means that the information of both orthorectified image and DSM was combined for the segmentation stage. For the current thesis this hybrid approach is the stage where the additional information from the DSM is expected to give more reliable and accurate information. The latter enabled the use of the elevation and colour information to identify and extract the damage features based on the two products but at the same time for the segmentation, it was also combined with the information from the RGB orthorectified image. This way the parameters of the segmentation algorithms were adjusted for each material and a final value for each case was selected. Thus, if a comprehensive segmentation is produced then the aim of the classification process is to assign in the segmented objects a respective class based on the predefined set of properties. The classification result will demonstrate the façade as a unique homogenous object and the potential damage in the classes as cracks or holes which then are used for the accuracy assessment. The final quality assessment of the classification is done based on a number of statistical measurement factors. In the end, the structural expert or civil engineer will derive a classification result on an interface showing the highlighted damage feature in accordance with its geometrical properties such as the maximum width, length and area but also its location. Based on this information, the specialist will be able to add an essential quantitative characterization analysis tool for the SDA procedure. In addition, the time to generate SDA after the event will be decreased substantial and the danger of in situ inspections will be eliminated (Figure 1).

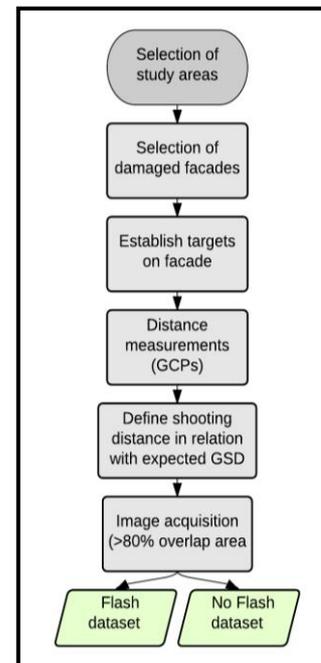
Figure 2. Flowchart of the image acquisition stage

The data acquisition was a crucial part in the current research (Figure 2). At first, an extensive work at the office was carried out to identify damaged areas that could be investigated to collect the damage information. The aim was to find façades that will constitute the base data of the study of the representative materials. When the damaged façades were selected the image acquisition was conducted. Artificial targets were created and printed in advance. These targets were attached on the façades to be used as GCPs for the sensor orientation. These points could not have been randomly placed on the façade but should shape an orthogonal as they were also used for the definition of the local coordinate reference system. The targets were removed after the image acquisition. Due to inaccessibility in some areas the image acquisition met some limitations such as difficulties to establish the GCPs on the building.

In the following step, multiple images were captured with an approximate baseline of 10-20cm to generate the 3D products that are going to be used in the image processing step. As a result, the image overlap exceeded the 80% which is sufficient for this case. If the disaster site is inaccessible from human experts for instance after a disaster in a nuclear plant, then an airborne platform will take the place of the specialists. The use of a UAV platform to perform a predefined flight path to capture damage features on high elevated infrastructure such as power plants tubes or installations will be time and cost efficient plus it does not put in danger the experts.

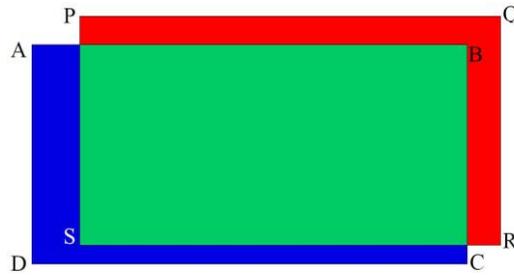
Figure 3. Illustration of the accuracy assessment (Joshi, 2010) Green: TP, Red: FN and Blue: FP

In Figure 2, an assumption is made; the rectangular ABCD is the reference data and the rectangular SROP is the extracted damage features area from the OBIA methods. Then three types of measurement factors could be defined. The green area or True Positives (TP) is the area which is present in the reference data but also in the extracted one from OBIA. Next, the blue area or False Positives (FP) is the area that is present in the reference dataset but not in the OBIA result. For instance, cracks that were identified as cracks in the manual digitization is not present in the post-classification stage. The red area or False Negatives (FN) is the area that was extracted as damage feature from the classification step, but it was not present in the reference.

Based on the previous three factors, four quality measurements could be obtained (Figure3) to represent the quantitative quality analysis of the classification. First, the split factor represents the number of true positives compared with the number of false positives. Second, the missing factor represents the number of false negatives compared with the number of true positives. The latter is a measurement factor to indicate the amount of missing information after the classification. Third, the correctness is a measure factor which represents the correct detection rate against the reference damage features. It ranges from 0-1 and it is represented in percentage (%). It is a factor which indicates if the reference damage information was correlated accurate with the classified damage features. Completeness is a factor which indicates how complete the extracted damage features are and it ranges from 0-1 like correctness factor.

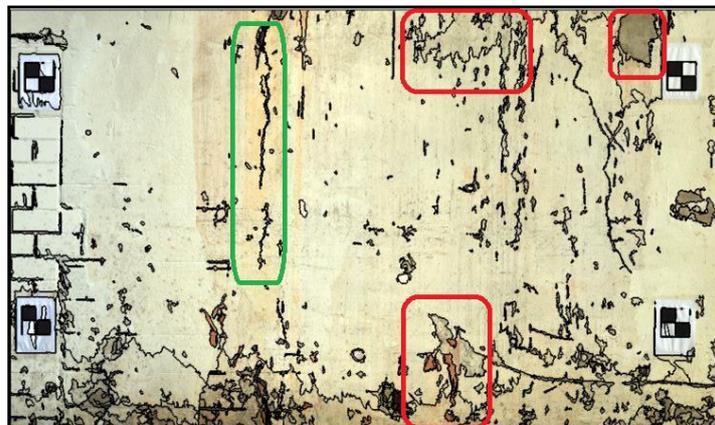
Figure 5. In the green area the actual cracks “concrete I”. In the red areas objects that were wrongly highlighted as independent objects after the segmentation process.

with the designed classification parameters the segmented artefacts were included as façade objects. In Figure 4, the result of the segmentation process in the sample “concrete I” is illustrated. In red rectangular boxes are presented the areas that are wrongly segmented as objects and are distinguished from the rest of the background due to their brightness values. In the green box the actual cracking feature that was identified during the field visit.

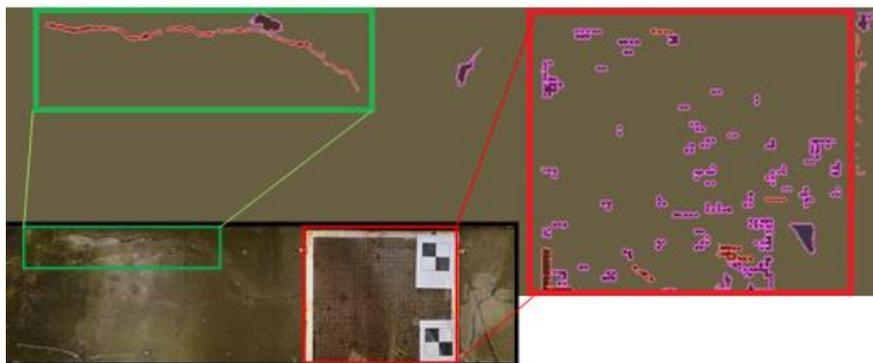
Figure 6. In the green area the actual cracks on the damage sample “concrete II”. In the red areas objects that were wrongly highlighted as independent objects after the segmentation process. At the down left part, the façade as it is in reality.

The aim of the classification step was to assign meaningful classes at the objects that were resulted from the segmentation process. The developed rulesets were able to identify a significant part of the damage features in most of the samples with high reliability. However, in some complex cases the resulted classification failed to detect even the visible damages with the current set of rulesets. The classification process was based on two major assumptions in the current thesis. The 2.5D DSM would provide elevation information of the damaged façade and the orthorectified image should provide the brightness information. As a result, in some cases where the obtained DSM had noise, the results from the image analysis step showed errors. For instance, in the sample of “Concrete II” one extra classification rulesets had to be designed in order to fulfil the requirement of a comprehensive classification. In addition, the DSM had different values between the flash and the no flash especially for the concrete and the brick. The latter is due to the fact that the flash light is augmenting the brightness values of the projected layers. This results in errors in OBIA process due to the modified parameters of the objects. Consequently, the developed set of classification rules on the flash dataset was not capable to be applied directly on the no flash dataset. Moreover, in the sample of “brick I” where a small hairline crack was present the developed ruleset for brick materials was not capable to extract the cracking feature due to its small size and also the current crack was not visible on the DSM as damage element. Due to high complexity in some of the damage samples, the classification process had been included some background objects wrongly. In Figure the result of the classification in the damage sample of “concrete II” is illustrated. As it can be seen the crack that exists in the upper left part of the image was identified reliably in the classification process. However, there are multiple small objects that were classified as holes. As it can be seen in the real photo, the current façade includes a rectangular box where the two targets are also attached. The rectangular box is window which was used to allow the transition of the air in the interior of the building. As a result, the small holes that it is constituted the box are classified as potential damage features and more specific as holes. In reality the current box is constituted from small holes, but they are not signs of damage. Also, a small part of the attached GCPs is classified with the rest artefacts as holes.
