## **IMPLEMENTING AN EFFECTIVE SEISMIC RISK MITIGATION STRATEGY FOR EXISTING READY MADE GARMENT FACTORIES IN BANGLADESH**

### **ABSTRACT**

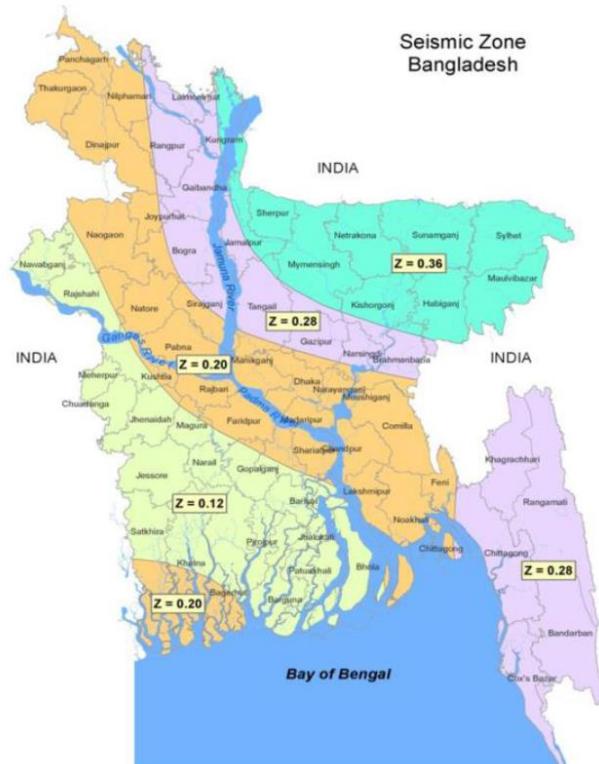
Figure 2. Seismic Hazard Map of Bangladesh for 475-year return period event (BNBC 2015).

The draft Bangladesh National Building Code (BNBC), dated 2015, has an updated seismic zonation map for Bangladesh (Figure 2) which follows a similar trace as the map of GSHAP.
