A MOBILE APPLICATION FOR MULTI-HAZARD PHYSICAL VULNERABILITY PRIORITIZATION OF SCHOOLS

ABSTRACT

This paper introduces a series of tools for a rapid yet reliable visual multi-hazard vulnerability prioritization of school infrastructure against potentially destructive natural hazards, i.e., earthquake, typhoon, and flood. The proposed tools can assist and speed up the process of identifying the most vulnerable school buildings for further decision-making. For each considered school, a set of parameters, including general information on the building and its occupants, structural and nonstructural characteristics, and secondary vulnerability modifiers, are first gathered. For each parameter, a vulnerability rating is assigned to its possible attributes, finally determining a vulnerability index for each considered school building exposed to earthquake, wind, and flood hazards. A mobile application has been developed for the entire process to assist the surveyors by increasing the efficiency and speed. The applicability of the proposed methodology and mobile application is tested by conducting an assessment of 115 elementary schools located in the city of Cagayan de Oro, Philippines.

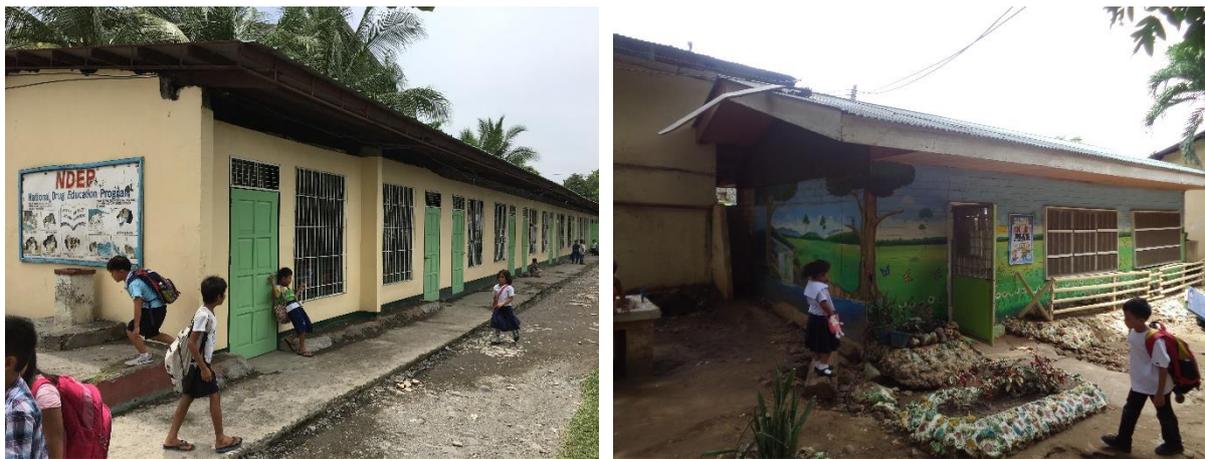
Figure 5. left: Kauswagan Central (ID: KAU08), right: Bulua Central (ID: BUL02)

As shown in Figure 4, 26 structures (22.6%) have high overall vulnerability ($VI > 50\%$), hence any more detailed structural assessment and retrofitting/strengthening planning should be prioritized for these buildings. The number of schools with moderate vulnerability is 78 (67.8%), while only 11 schools (9.56%) are characterized by a vulnerability index lower than 30%. Accordingly, the most vulnerable surveyed structure is KAU08 ($VI = 64.8\%$), i.e., a highly deteriorated masonry structure with unreinforced bearing walls, built in 1983, and located in Kauswagan Central School (Figure 5-left). Similarly, BUL02 ($VI = 60.5\%$; Figure 5-right) is a timber frame, single story, built in 1985, consisting of one classroom ($9\text{m} \times 4.8\text{m}$) with timber supports for its roof. The general condition of the structure as well as its roof and the connections have been described deteriorated. In both cases, the buildings were susceptible to pounding effect and short column.

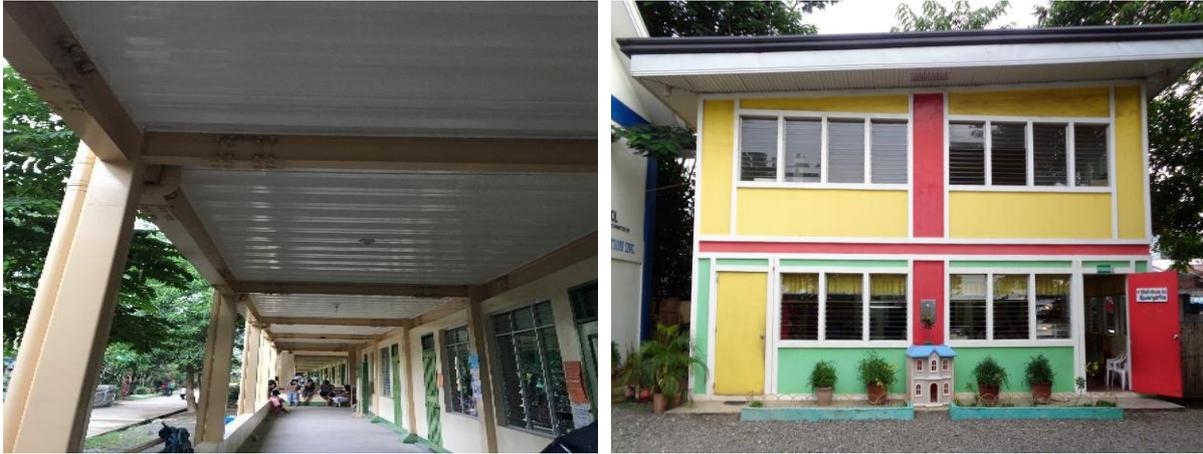
Figure 6. left: West City Central (ID: WES12), right: South City Central (ID: SOU16)

On the other hand, the structure with the lowest vulnerability index ($VI = 26\%$) is an isolated, brand new steel frame building in West city central school compound (ID: WES12). The building consists of two storeys ($25.6\text{m} \times 6\text{m}$) and four classrooms in excellent condition and no report on obvious deficiencies (Figure 6-left). Similarly, a RC building, located in south city central school complex scored a vulnerability index of 29.9% (Figure 6-right).

The building was built in 2012, consists of two floors and two classrooms with a steel truss roof. According to the collected data, the building is in an excellent condition with high-quality connections between the columns and the roof and no visible deficiency is observed.

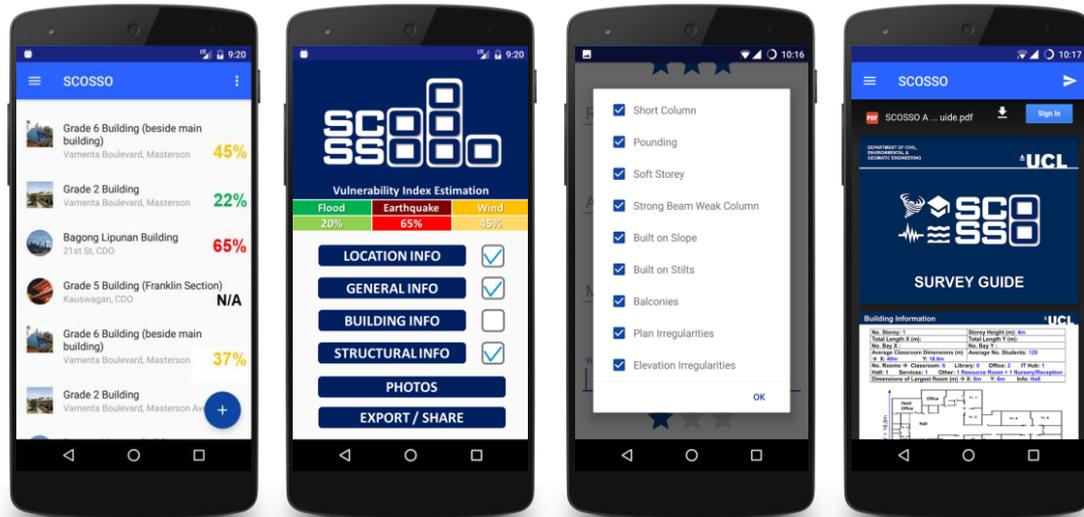
Figure 8. Interface of SCOSSO Mobile Application

A mobile application, SCOSSO App, has been developed to assist the surveyors by increasing the efficiency, precision and speed of the rapid visual survey. The discussed surveying form has been implemented completely in the application, featuring a simple and user friendly interface. The app is capable of evaluating the physical vulnerability of the surveyed buildings in real time for different hazards, including earthquake, flood and strong wind. Users can capture photos of the surveyed structures through the app, as it automatically allocates them to the relevant survey data. The surveying data is stored in the device and the cloud and can be easily shared via email or extracted as .csv file. Beside the traditional latitude and longitude location indicator, a built-in locator with a high precision of 3m in 3m is also included by implementing the What3Word extension (<https://what3words.com/>). Furthermore, a comprehensive offline surveying guide is provided, demonstrating different aspects and options of the app through visual examples. The SCOSSO mobile application is freely available through the Google Play Store (Figure 8).
